## SHORELAND ZONING PERMIT APPLICATION

### **Harrison Avenue Slope Repair and Stormwater Improvements Gardiner, Maine**

**Re:     *Shoreland Zoning Permit Application  
          Harrison Avenue Slope Repair and Stormwater Improvements  
          Gardiner, Maine***

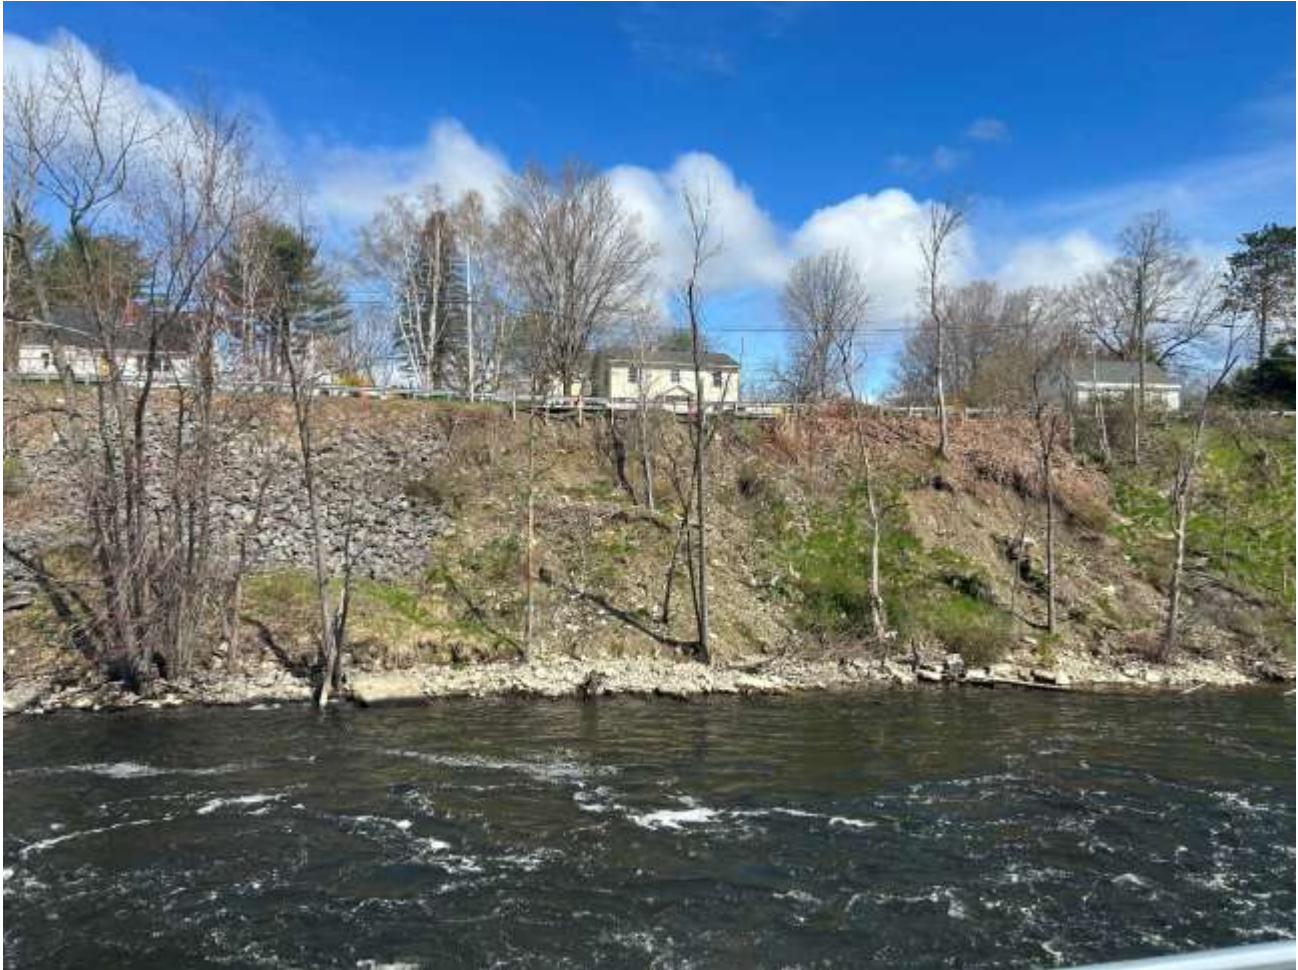
*Image 1-1: View of May and December 2023 slope failures taken on May 5, 2024*

The failures also caused undermining and loss of supporting soil along the eastern edge of the paved surface of Harrison Avenue. Soil loss was observed around the posts supporting the existing metal guardrail, further reducing the stability of the roadside safety barrier. In addition, the failures reduced the lateral support for a nearby timber utility pole located along the east side of the roadway. As a result of the soil loss, the pole has rotated toward the slope and is considered structurally compromised.

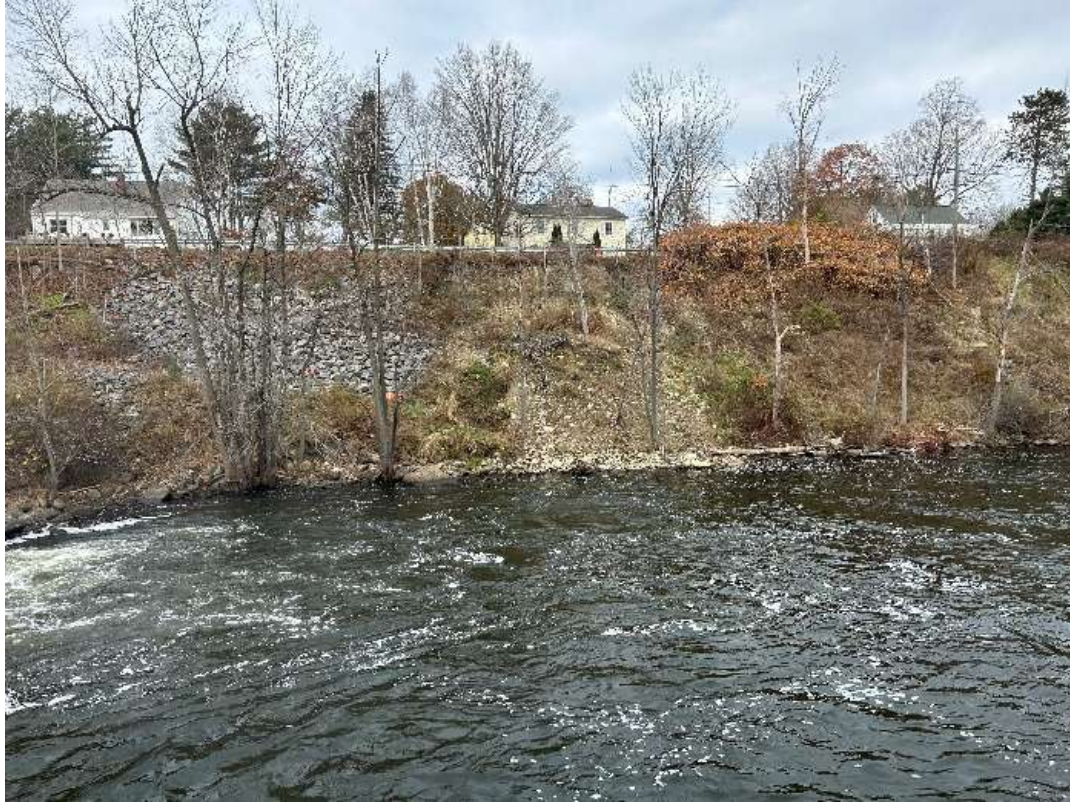
*Image 1-3: View of site after May 2023 but before December 2023 failure taken on November 14, 2023*

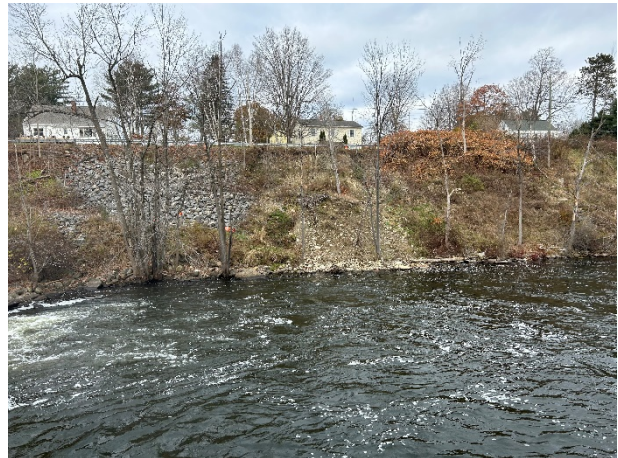
*View of May 2023 slope failure on November 14, 2023*

The failure caused undermining and loss of soil material along the east side of the paved surface of Harrison Avenue and around the metal guardrail support posts. The failure also caused reduced lateral support of a timber utility pole that, as a result, is structurally compromised and has rotated towards the soil slope. Harrison Avenue in the area of the slope failure has been closed to public vehicular traffic due to safety concerns. Photos of the failed slope and damaged infrastructure are included in **Appendix B**.

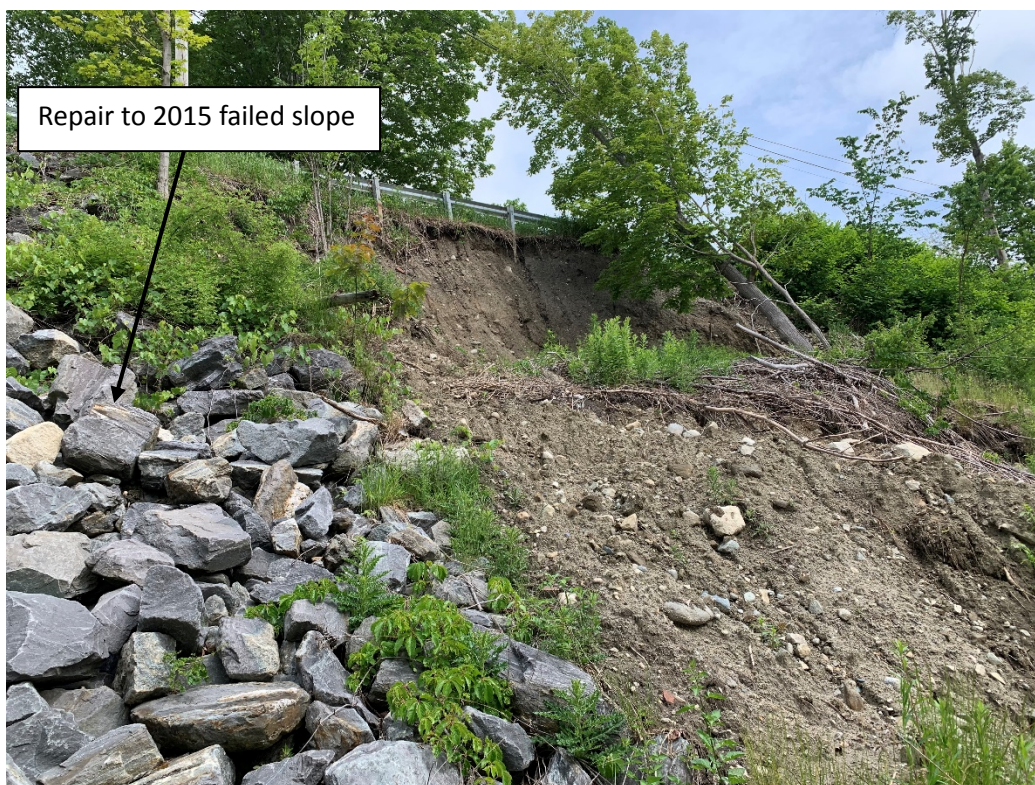
Photo 2 – Top section of failed slope on June 8, 2023

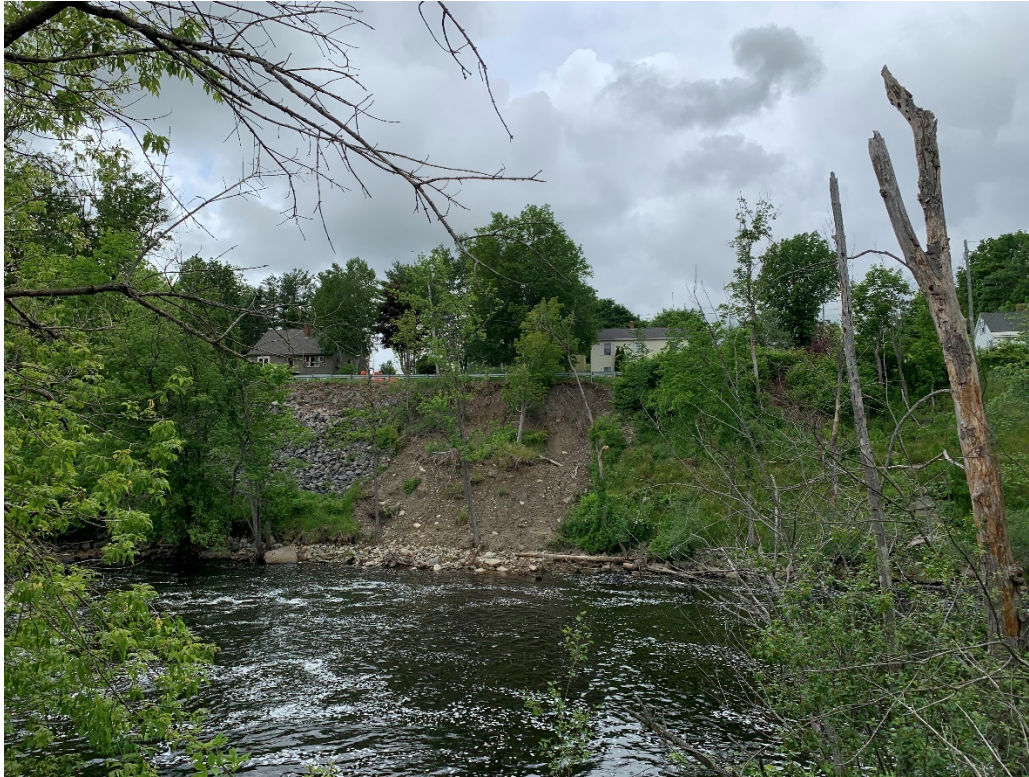
Photo 3 – Failed Slope from east side of Cobbosseecontee Stream on June 8, 2023.

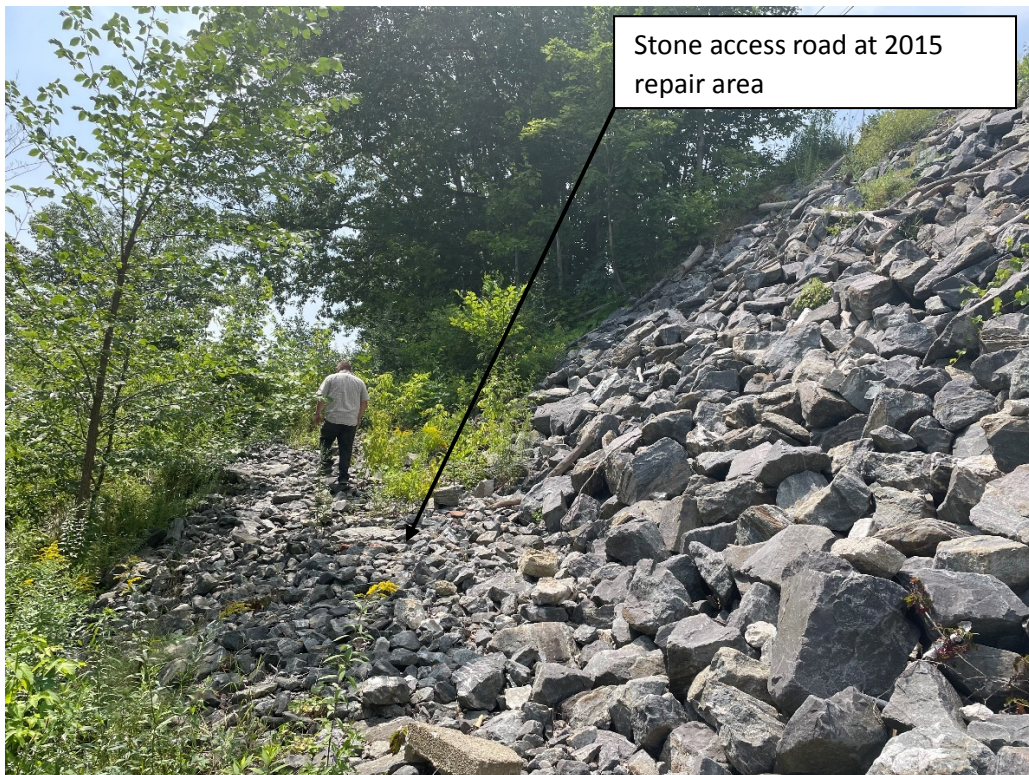
Photo 4 – Section of slope repaired after 2015 failure on August 3, 2023

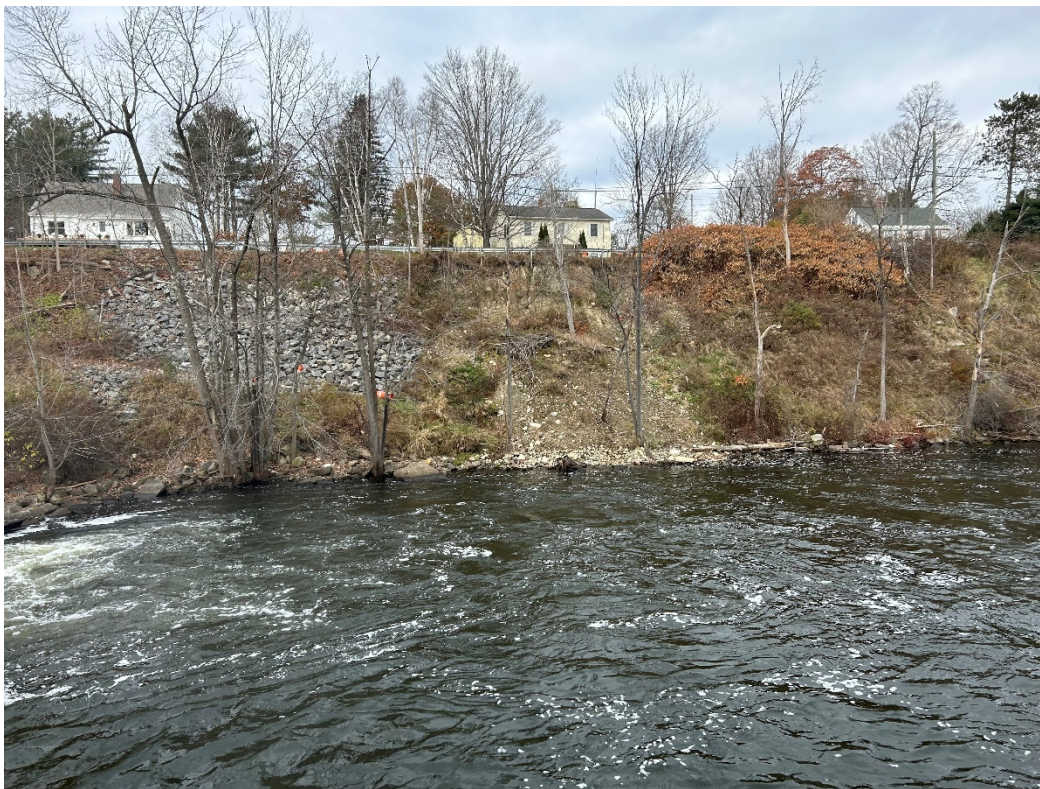
Photo 9 – Failed Slope from east side of Cobbosseecontee Stream on November 14, 2023.

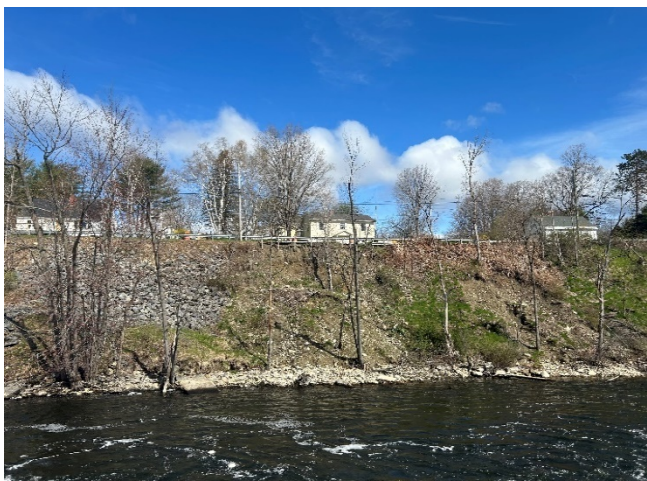
The section of Harrison Avenue slope that failed on December 18, 2023 is located approximately 200 feet downstream (north) of the New Mills Dam and approximately 20 feet north of the May 1, 2023 slope failure (see photo to the right). The dam's outlet control is located on the left (west) side of the dam, on the same side of the Cobbosseecontee Stream as the slope failure. The failure occurred during a period of significant rainfall and stormwater runoff, and high flow velocities in the Cobbosseecontee Stream and over the spillway and through the outlet control of New Mills Dam. Similar conditions were evident at the time of the May 1, 2023 failure. The failure caused surficial soils and most vegetative cover to slide into the Cobbosseecontee Stream and left a deep sloughed slope exposing embankment soils. The failed section of slope measures approximately 40 feet wide by 75 feet tall by 4 feet deep.

*View of May & December 2023 slope failures on May 3, 2023*

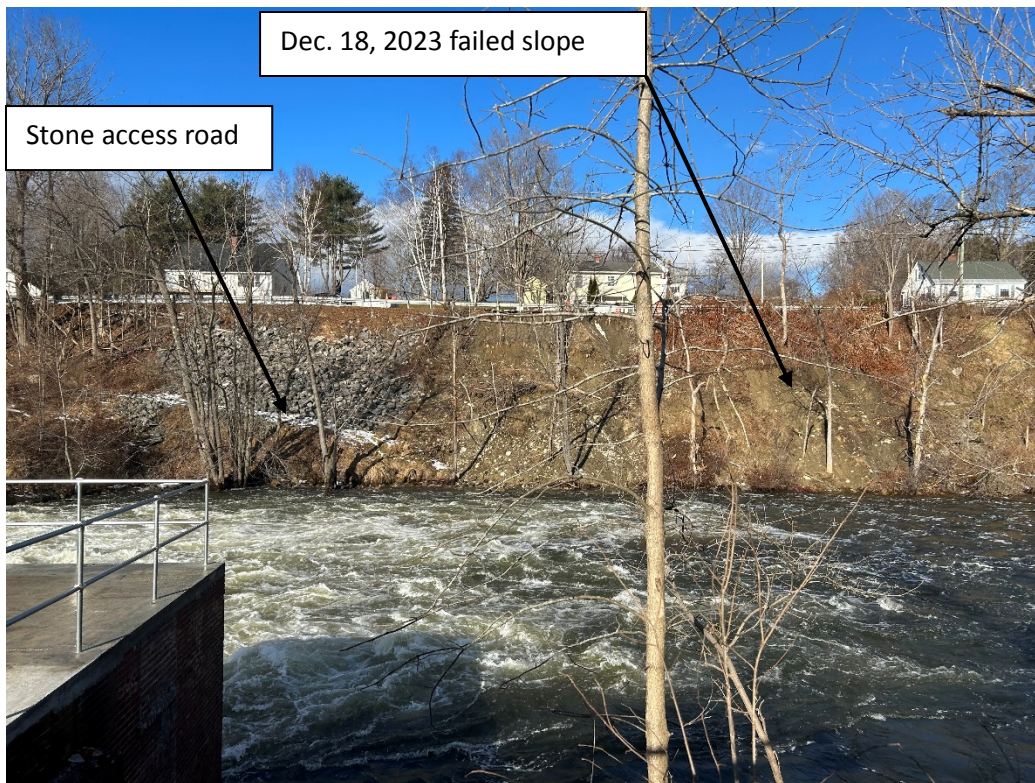
Photo 2 – Failed slope and stone access road on January 12, 2024

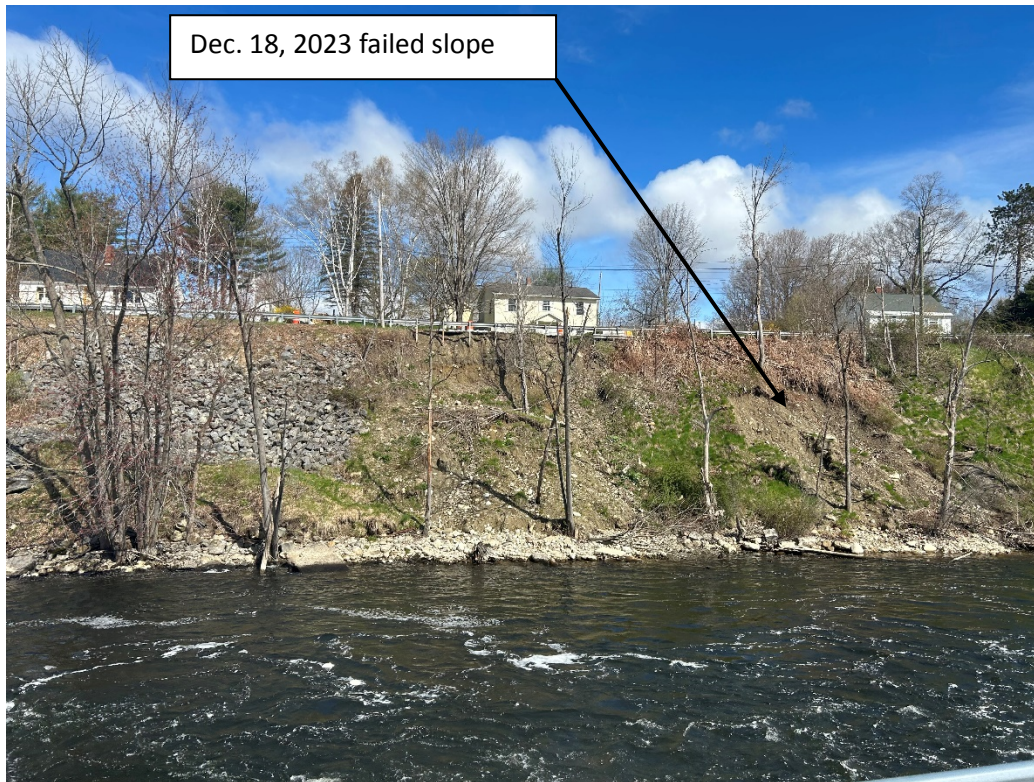
Photo 3 – Failed Slope on May 3, 2024.

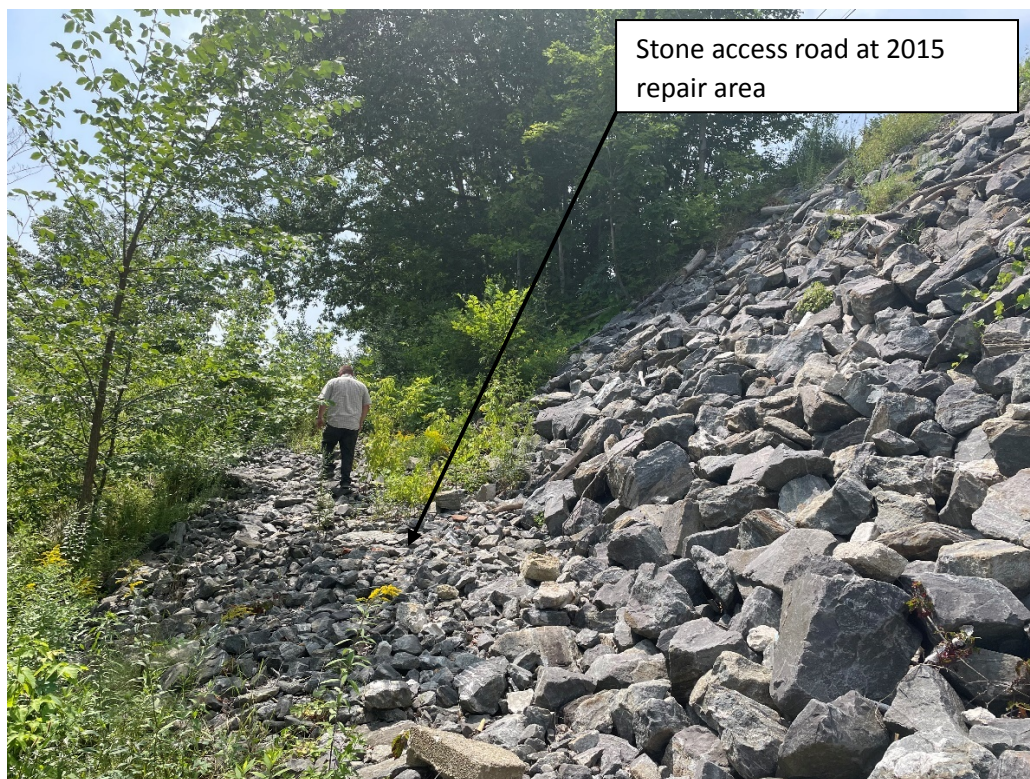
Photo 4 – Section of slope repaired after 2015 failure on August 3, 2023

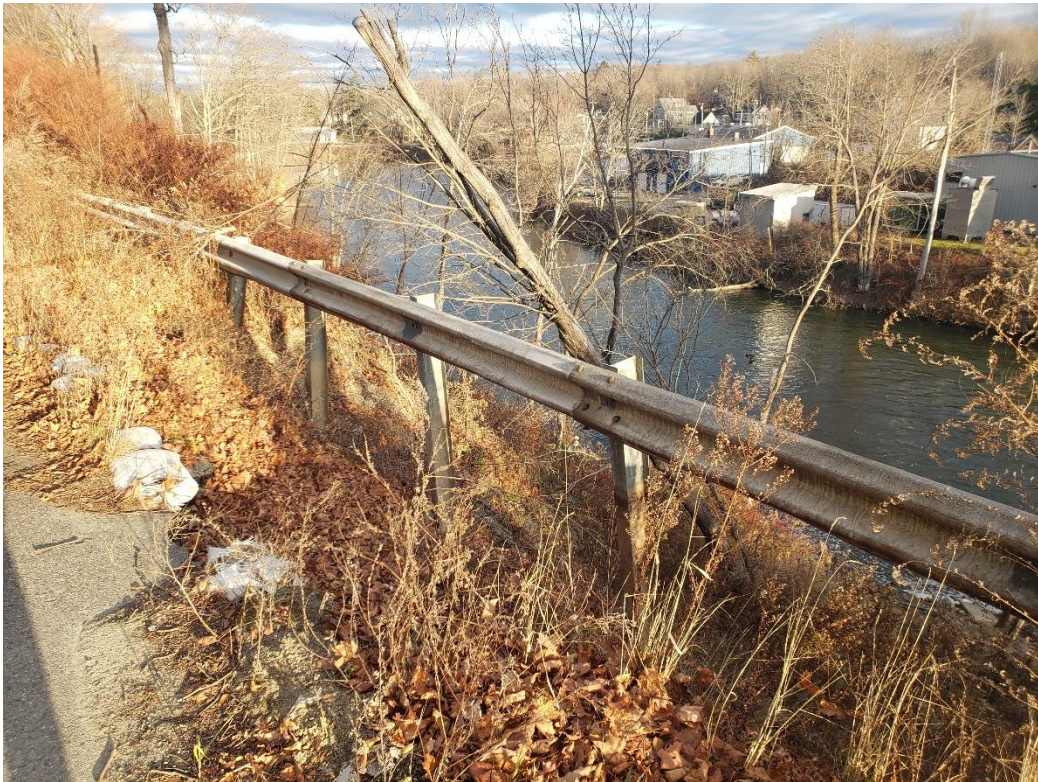
Photo 8: Guardrail and road edge at top of slope failure. Looking east.

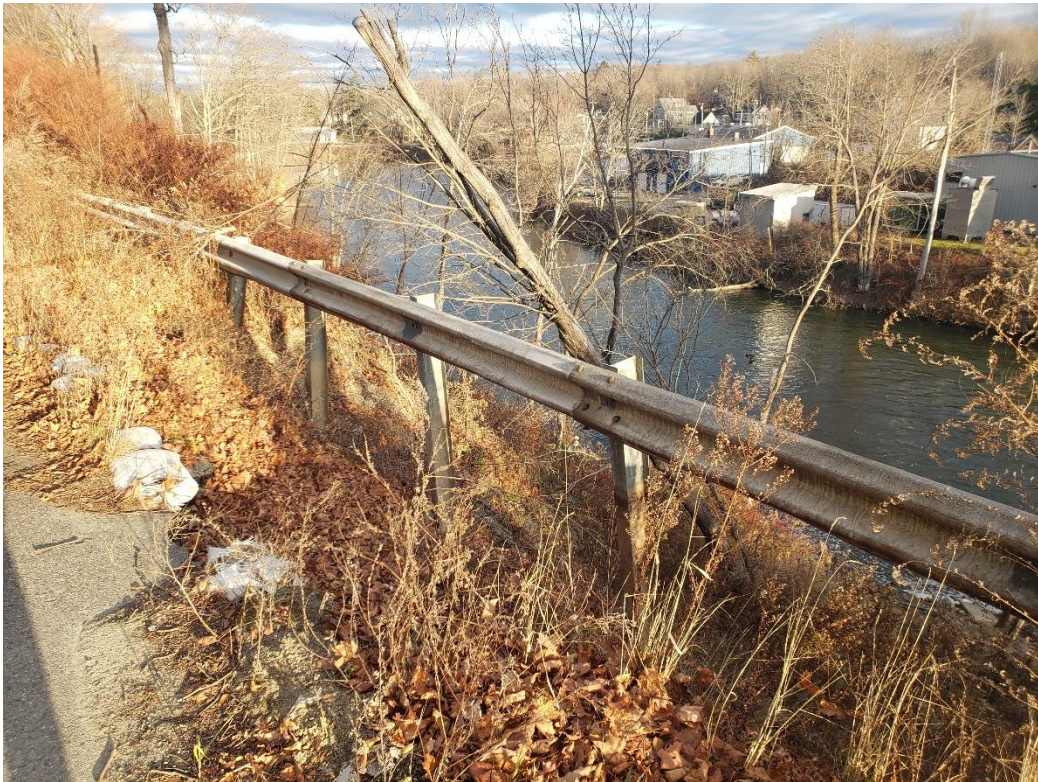
Photo 8: Guardrail and road edge at top of slope failure. Looking east.
