# City of Gardiner

## Flooding Impacts & Community Risk Assessment

Final Report | February 2026

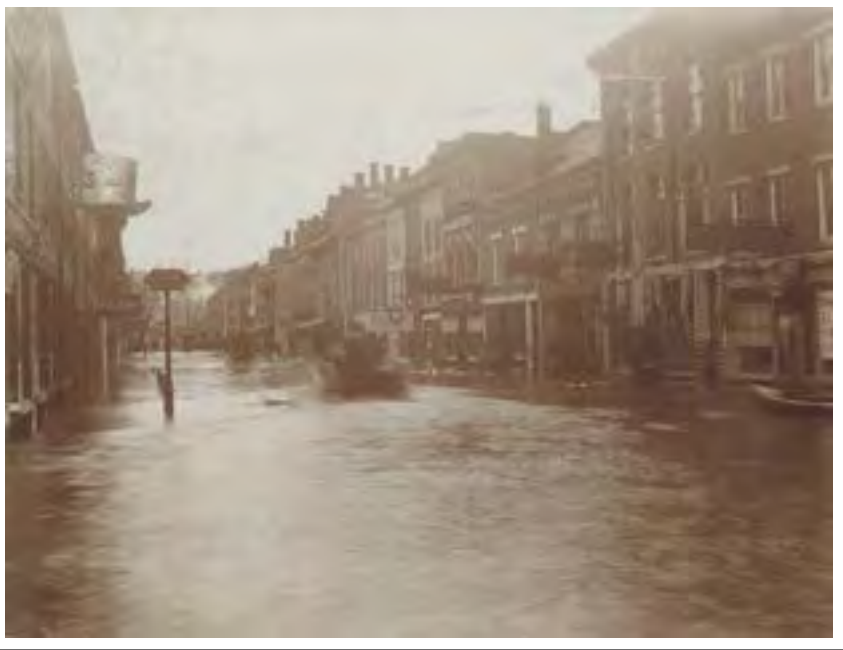
1896

Source: Historical photos provided by Dawn Thistle, Archivist, Gardiner Public Library.

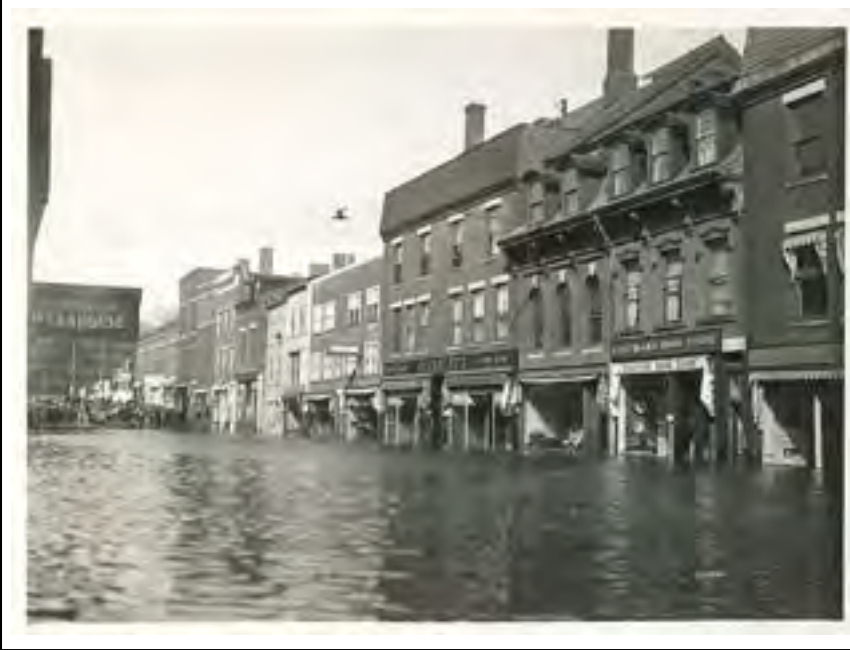
1936

Source: Historical photos provided by Dawn Thistle, Archivist, Gardiner Public Library.

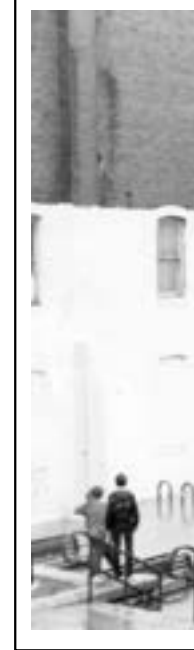
1987

Source: Historical photos provided by Dawn Thistle, Archivist, Gardiner Public Library.

This is the flood of record; it was caused by both a large rain event and ice jams.

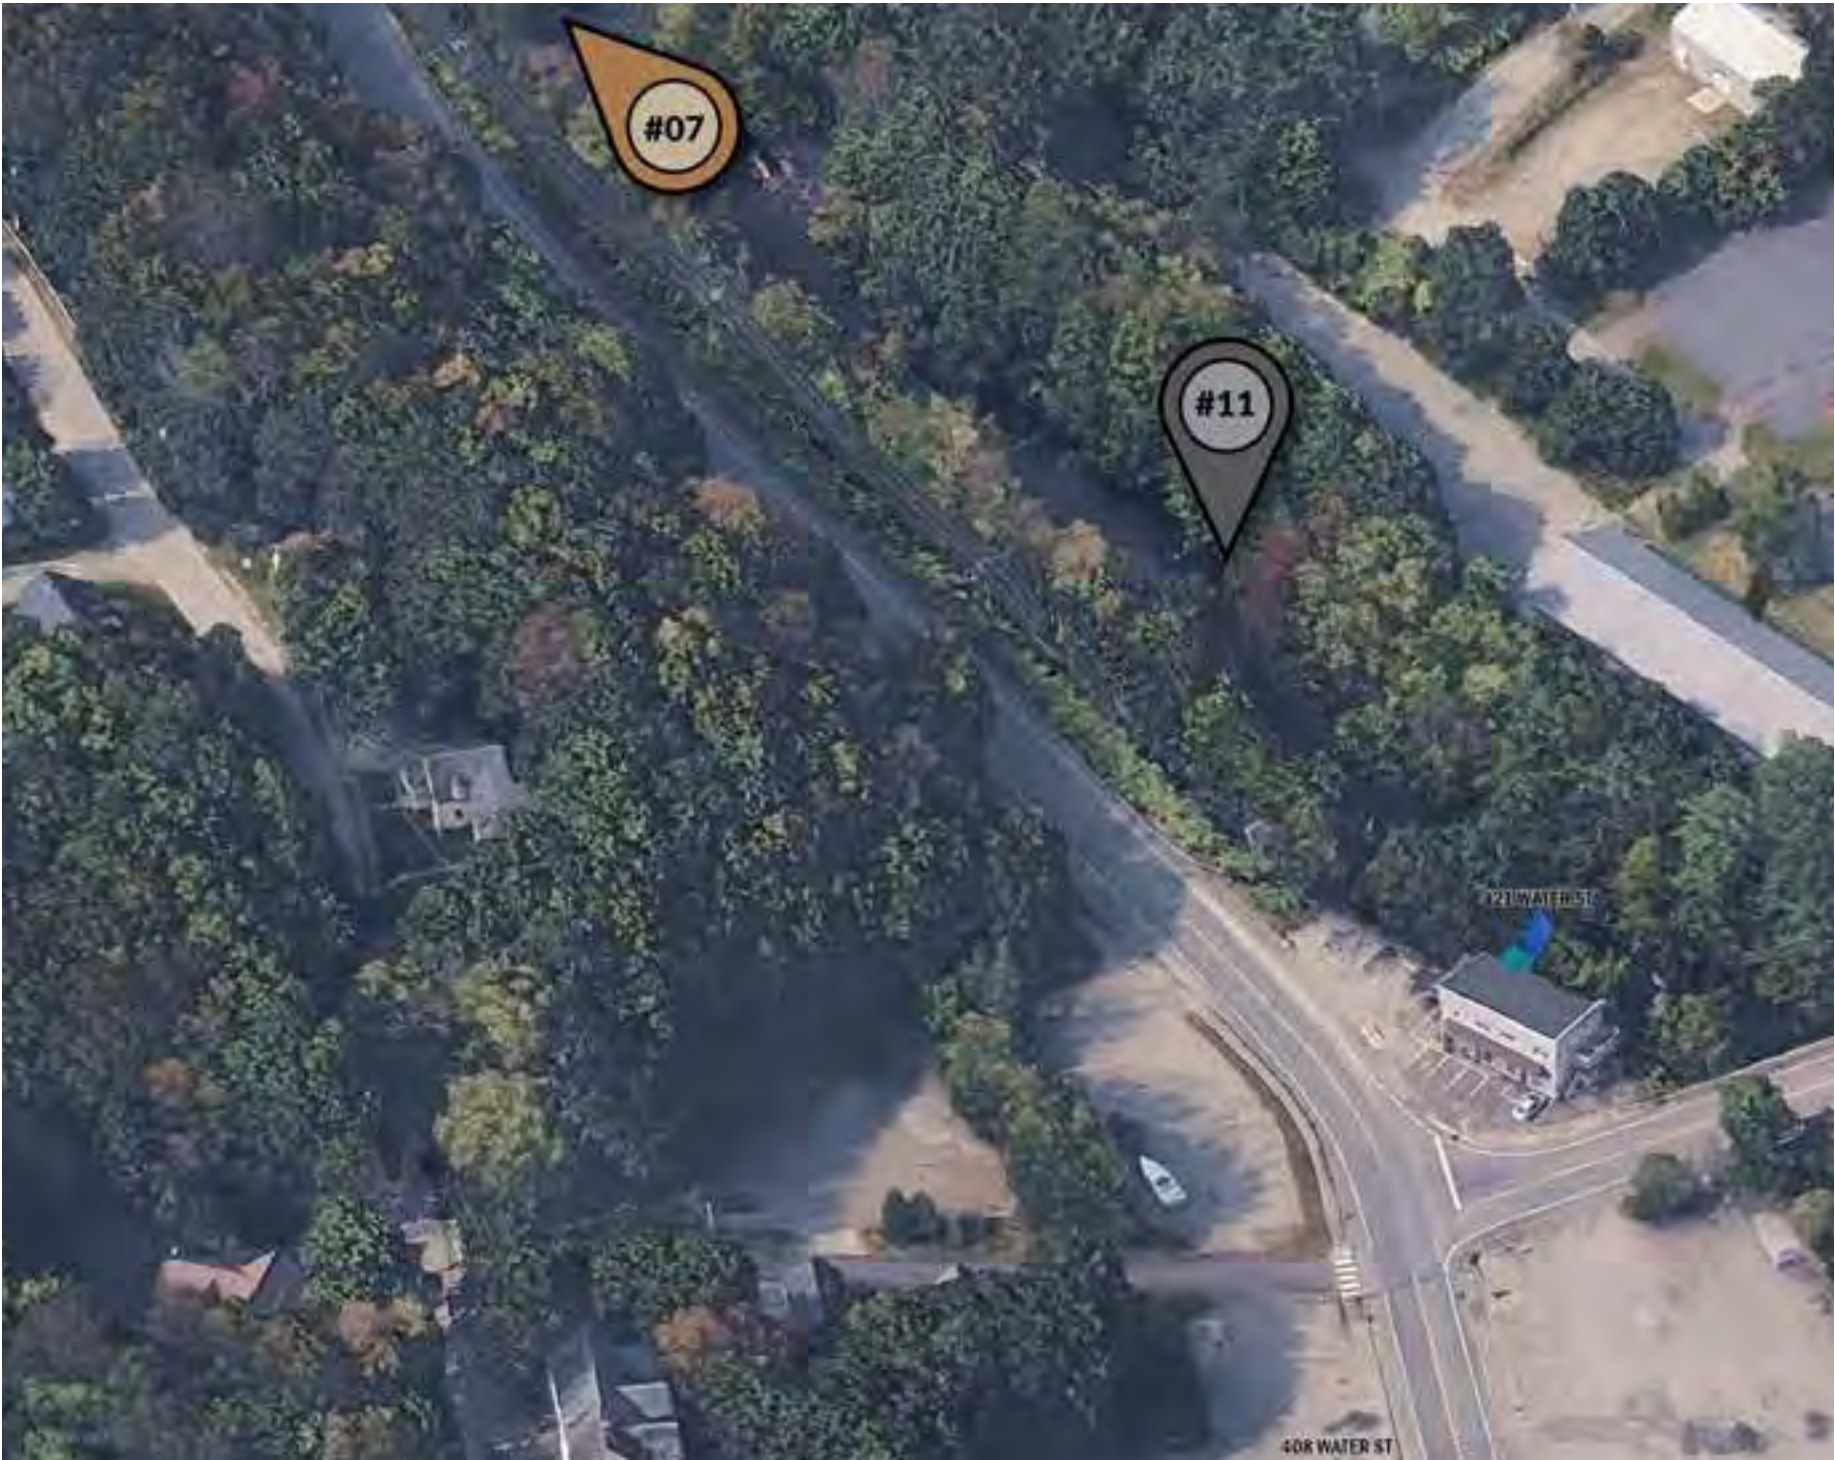
The Dog Park is on a steep slope which may be susceptible to some erosion from stormwater and extreme Cobbossee flooding events, but it is not directly impacted by the Kennebec River’s floodplain. This area is therefore considered to have a negligible environmental hazard.

(See 3D map for full extent)

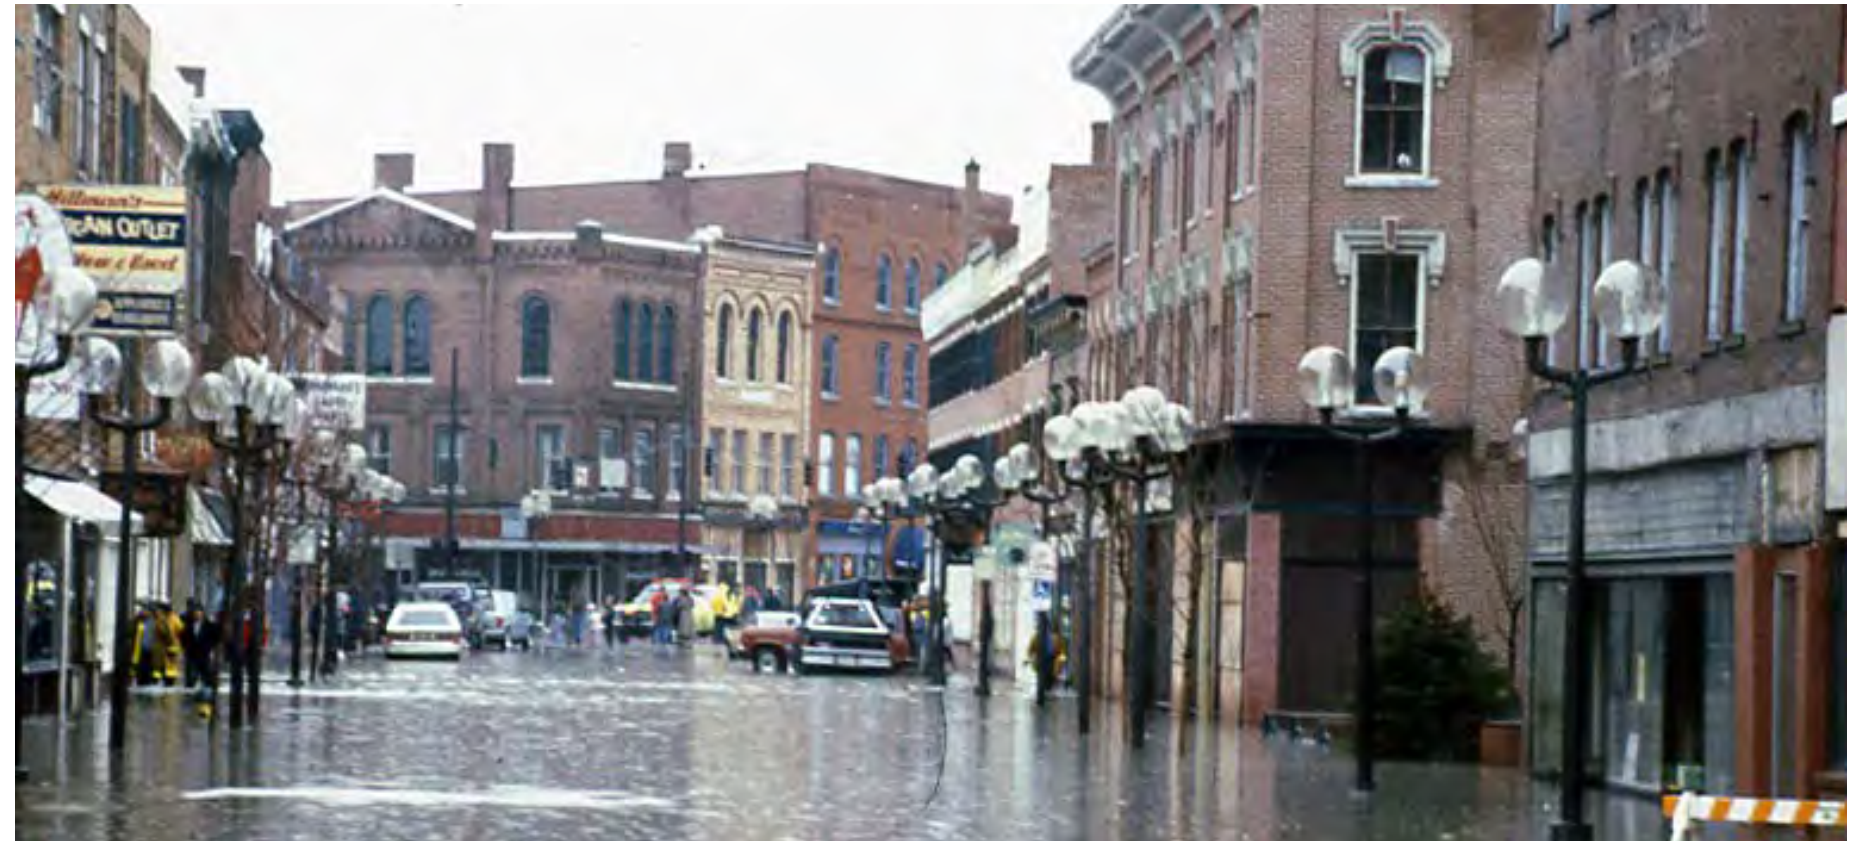
*Photo of 1987 Flood on Water Street*

Due to its proximity to the Kennebec and Cobbosseecontee, Water Street structures are highly susceptible to river flooding. There have been numerous historic floods which have severely inundated the street and its businesses (see top image on previous page and historical timeline). Due to the elevation and past reported floods, this asset is considered as being in a high-hazard area.

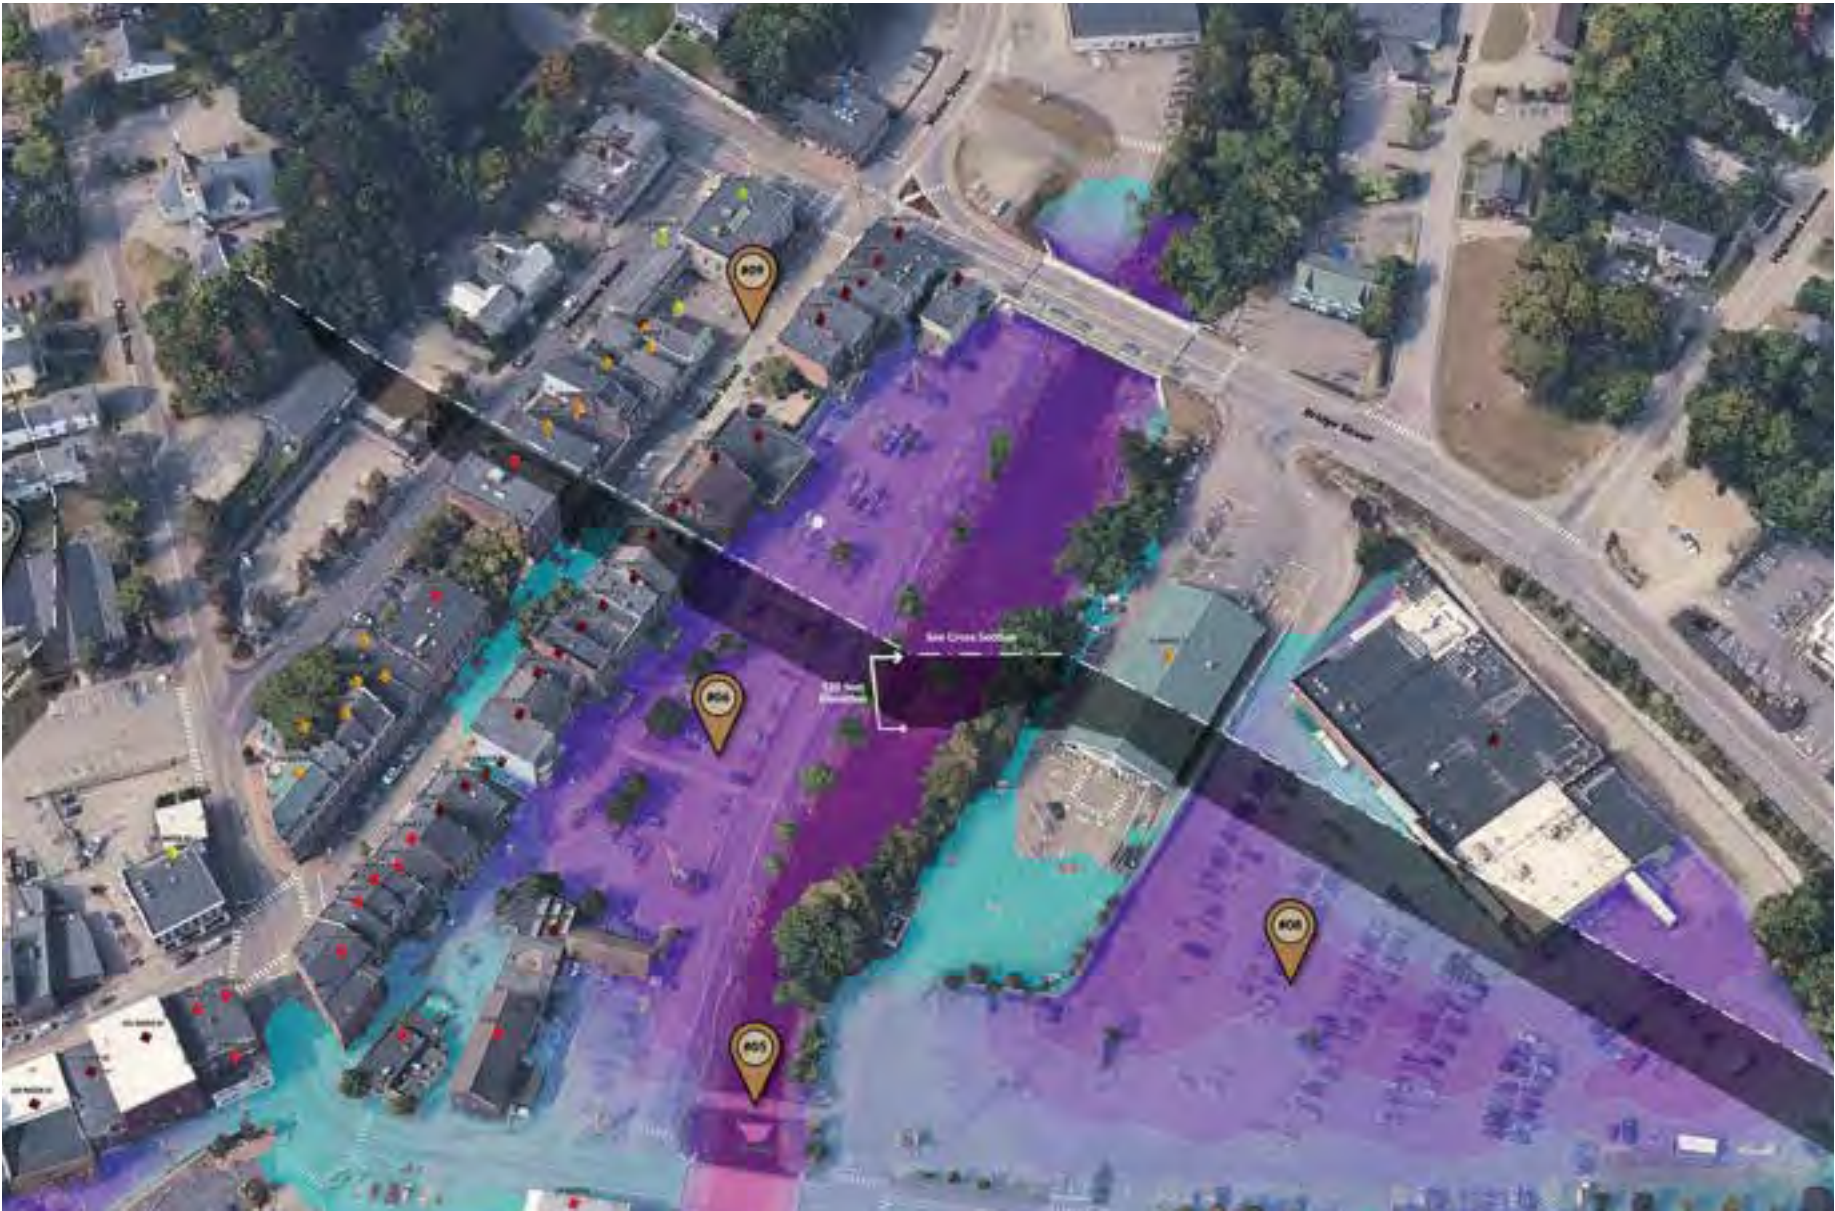
(See 3D map for full extent)

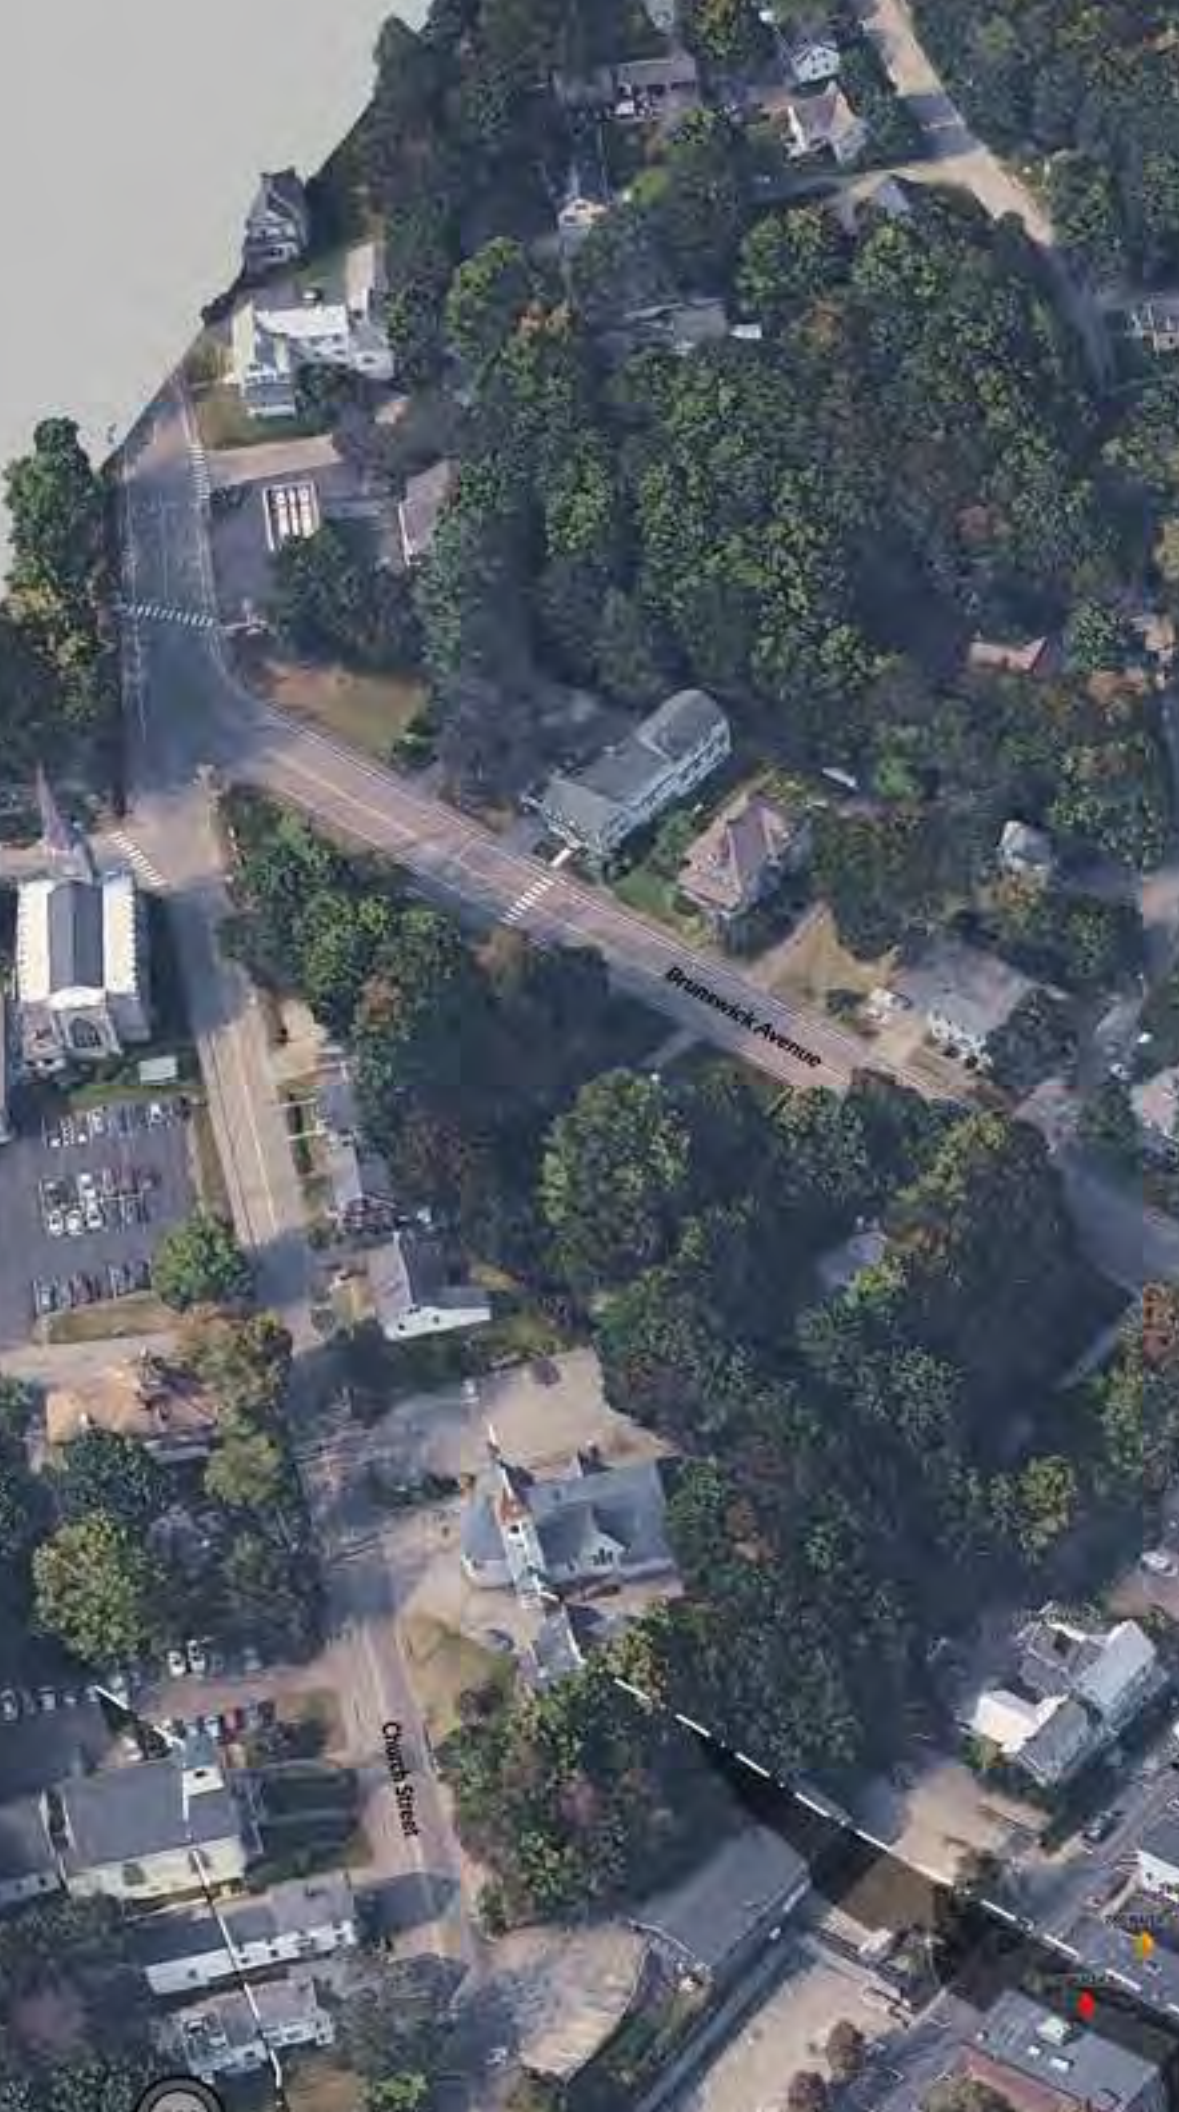
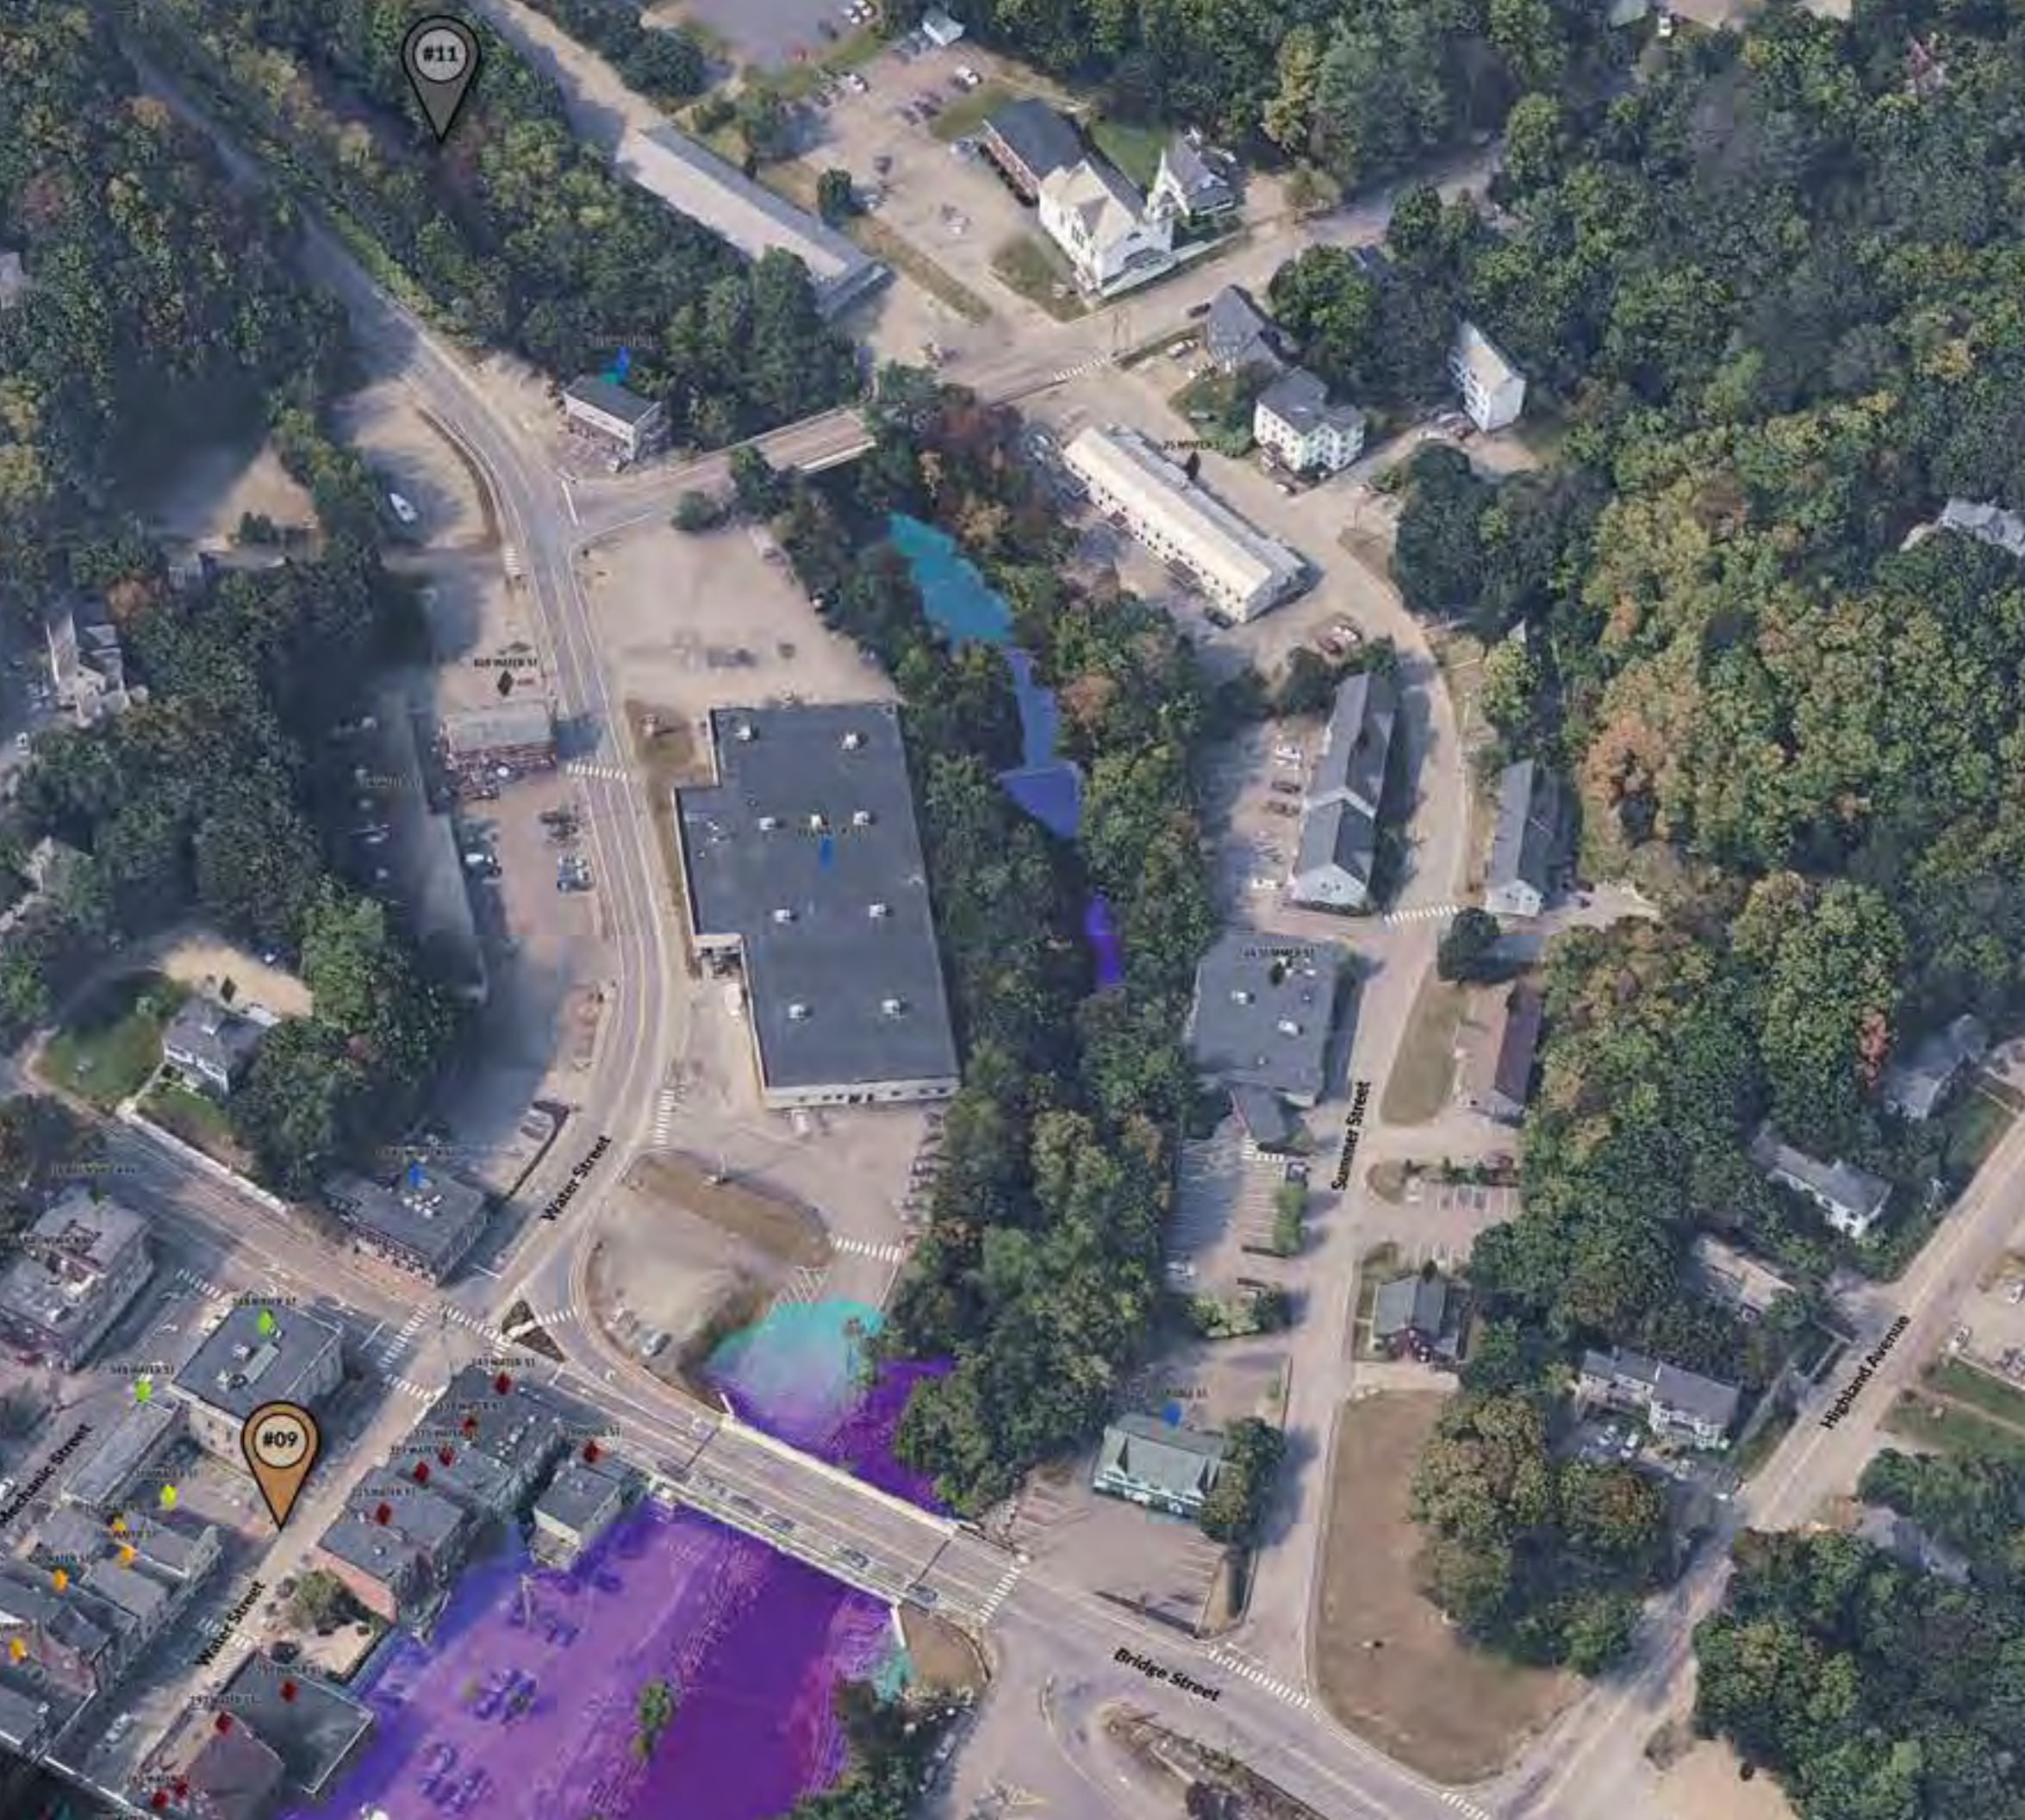
### BFE vs. LAG Above/Below

The map displays recommendations for structures only. Each structure in the floodplain has a “footprint” that was improved using high-resolution imagery, LiDAR, and some on-the-ground site walks. These footprints were compared against the high-resolution topographic information for the area to establish the Lowest Adjacent Grade (LAG) for each—the lowest height of land immediately adjacent to the building’s footprint. This LAG was then compared against the Base Flood Elevation (BFE). The difference between the two informs the strategy recommended.

The map is an oblique view looking west and is split into two sections. The first page is the western part of the floodplain, and the second page is the eastern part directly adjacent to the river. Also found on this map are the lines representing cross section visuals found previously in the report.

The map included on this page and the following were generated for reference only. These are not authoritative assessments for each property; they should instead be considered general recommendations based on a data analysis using the best information available without an on-the-ground site visit.

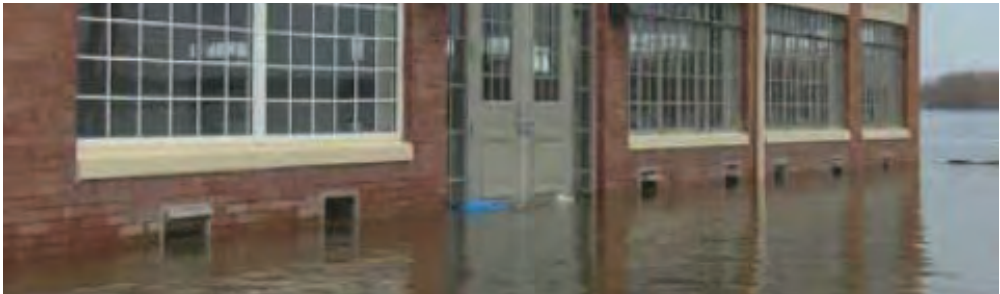
## Flood Openings

Prevent structural collapse from the pressures of standing water by allowing water in. Examples of flood openings include:

- First floor door.
- Garage door.
- Flood vents.
- Garage and basement openings.

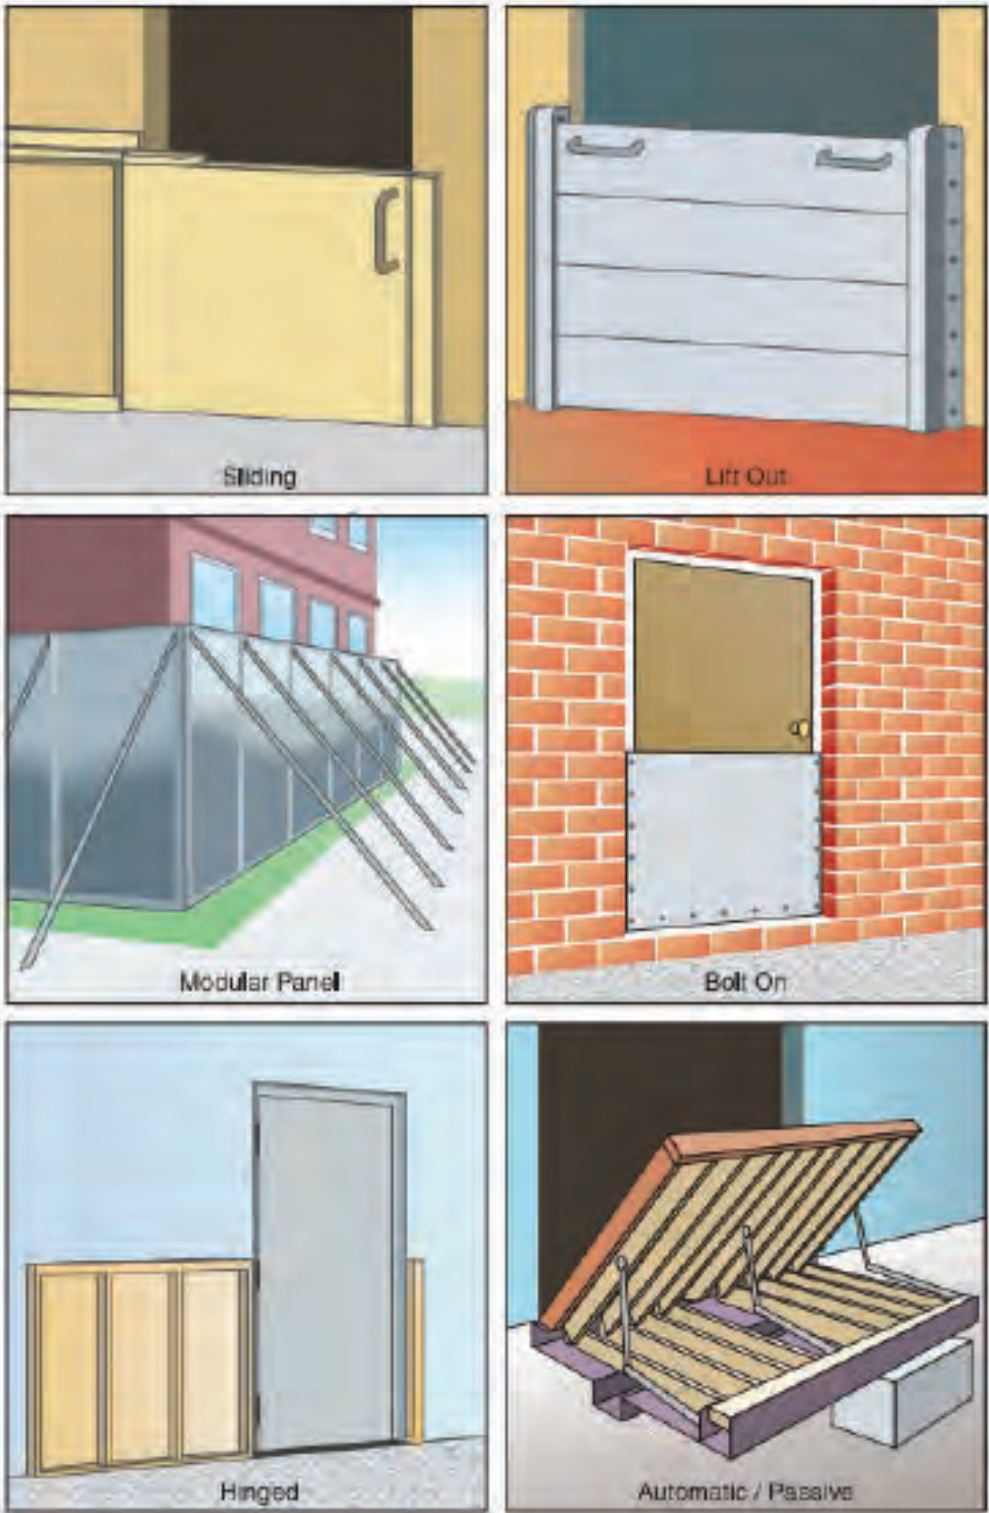
FEMA P-936, 2013

Due to hydrostatic pressure and structural stress, this treatment is only recommended when load-bearing masonry buildings or frame buildings with masonry foundations can be properly evaluated by a structural engineer.

BFE must be below the top of the foundation (and/or the masonry walls) and be properly designed (or reinforced) to withstand floodwaters. This is not a good solution for wood construction.

- Dryproofing treatment requires regular maintenance, monitoring, and repair to perform effectively in repetitive flood events. May require permits/engineering.
- Not recommended if expected flooding is higher than 3 feet due to hydrostatic pressures.
- Any building opening and/or component (including utilities) below the BFE must be able to withstand hydrostatic forces.

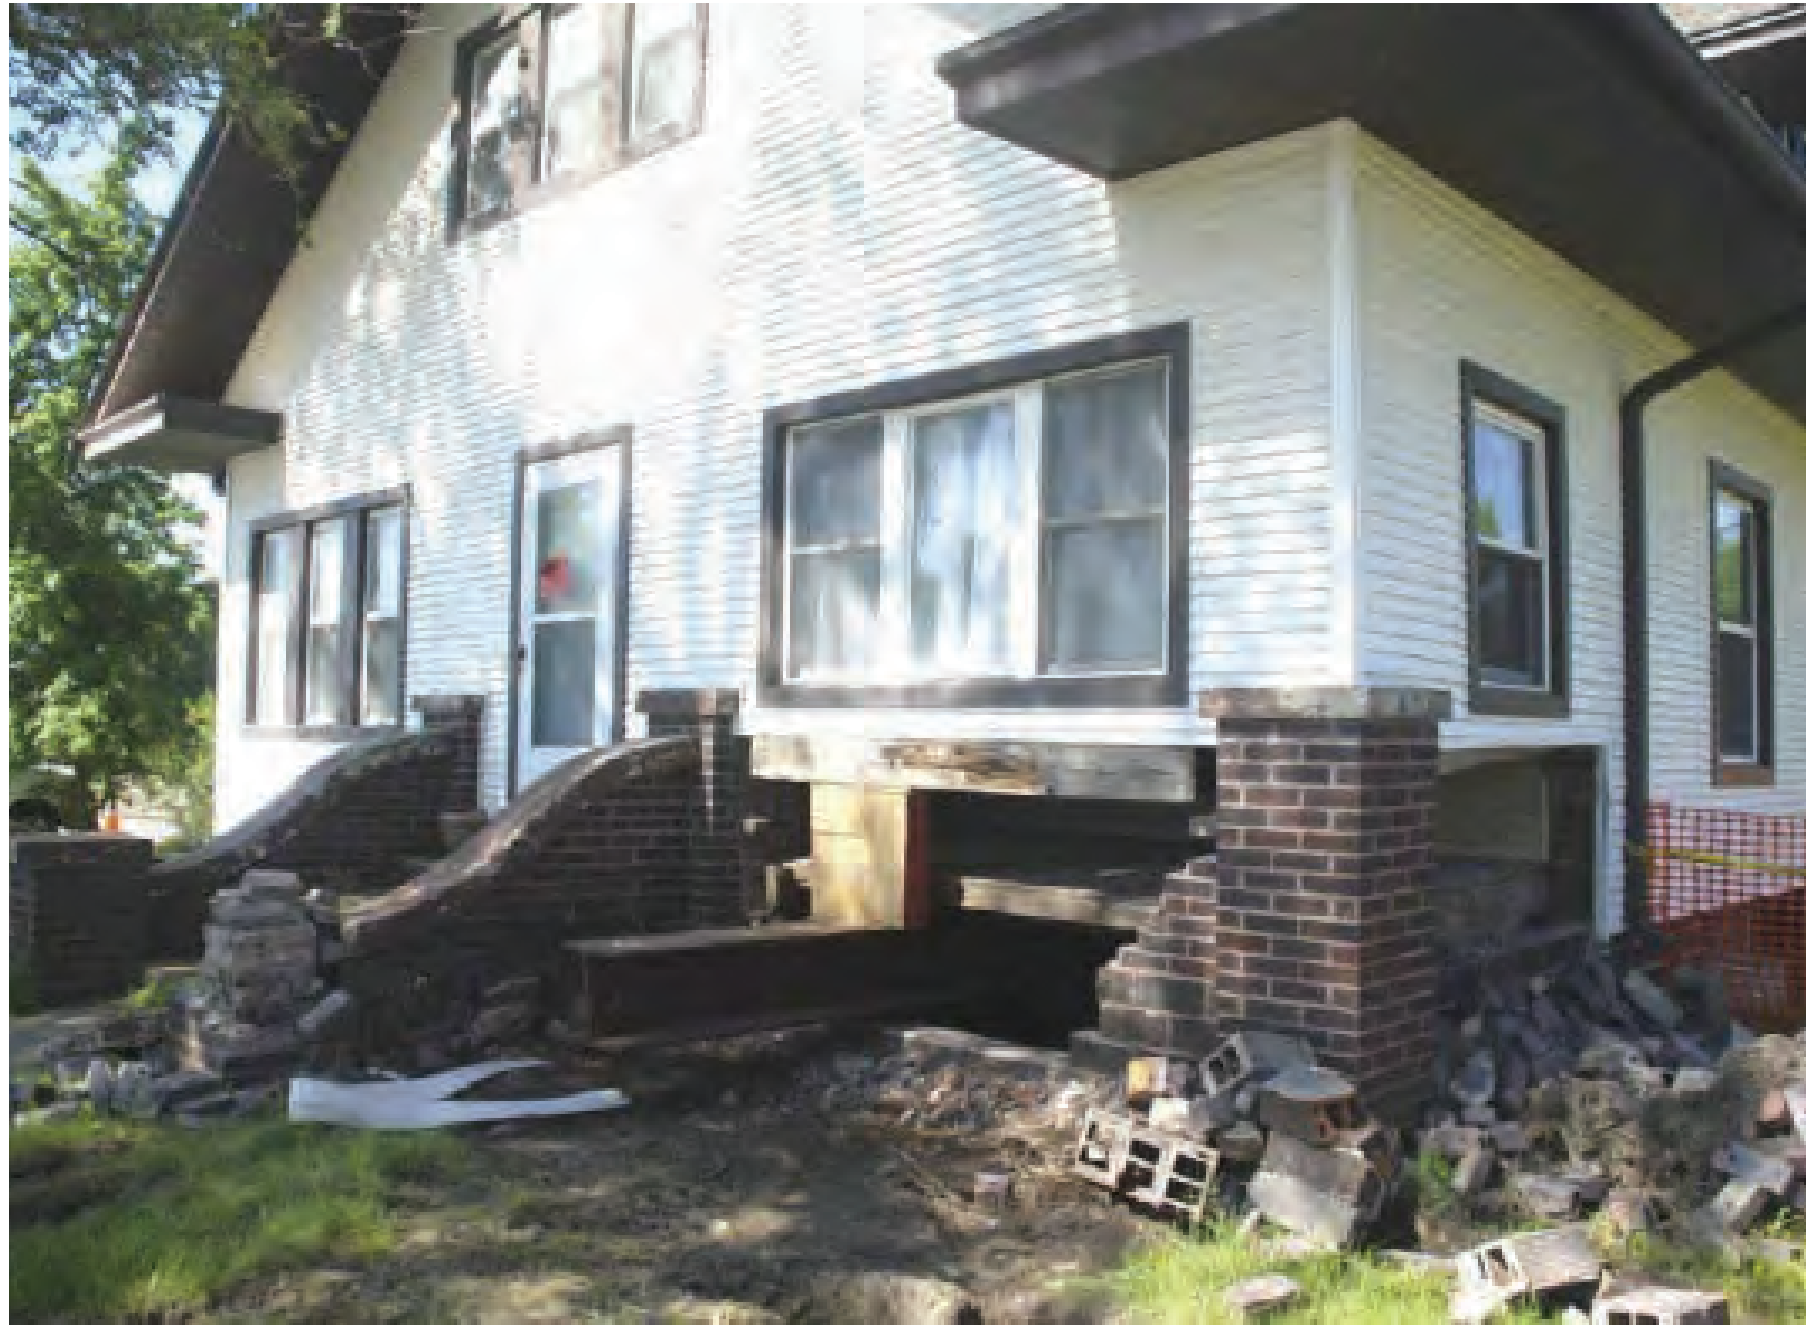
NPS Flood Adaptation Guidelines 2021

Example of a building in the process of filling the lowest level. Shows access points for equipment to fill the level which will be removed upon completion.

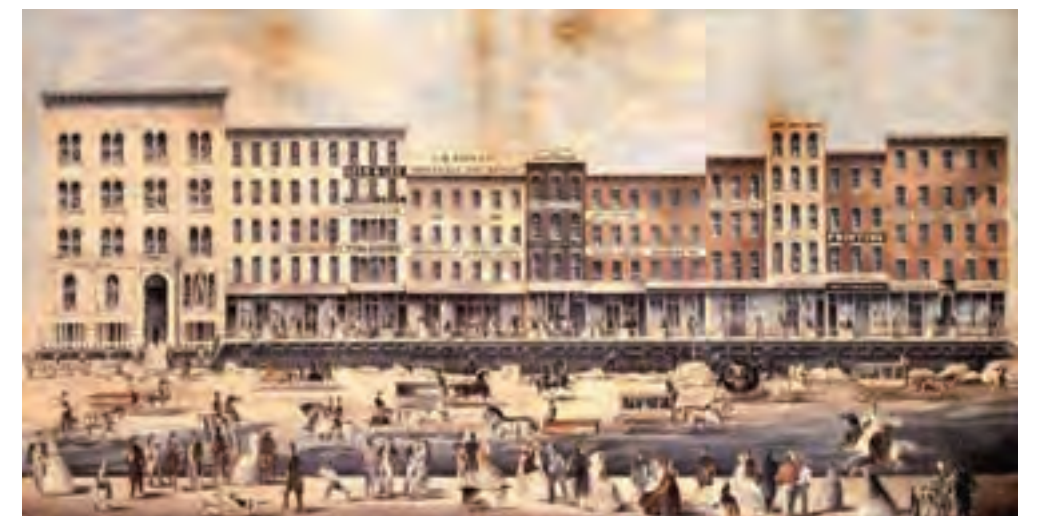
Chicago History Museum, IChi-059709

This illustration demonstrates a merchant block in Chicago (1857) where all buildings were elevated at one time as part of a larger plan to elevate the downtown area by four feet. Elevating masonry buildings can be difficult but has been done historically.
