## SHORELAND ZONING PERMIT APPLICATION

### **Harrison Avenue Slope Repair and Stormwater Improvements Gardiner, Maine**

**Re:     *Shoreland Zoning Permit Application  
          Harrison Avenue Slope Repair and Stormwater Improvements  
          Gardiner, Maine***

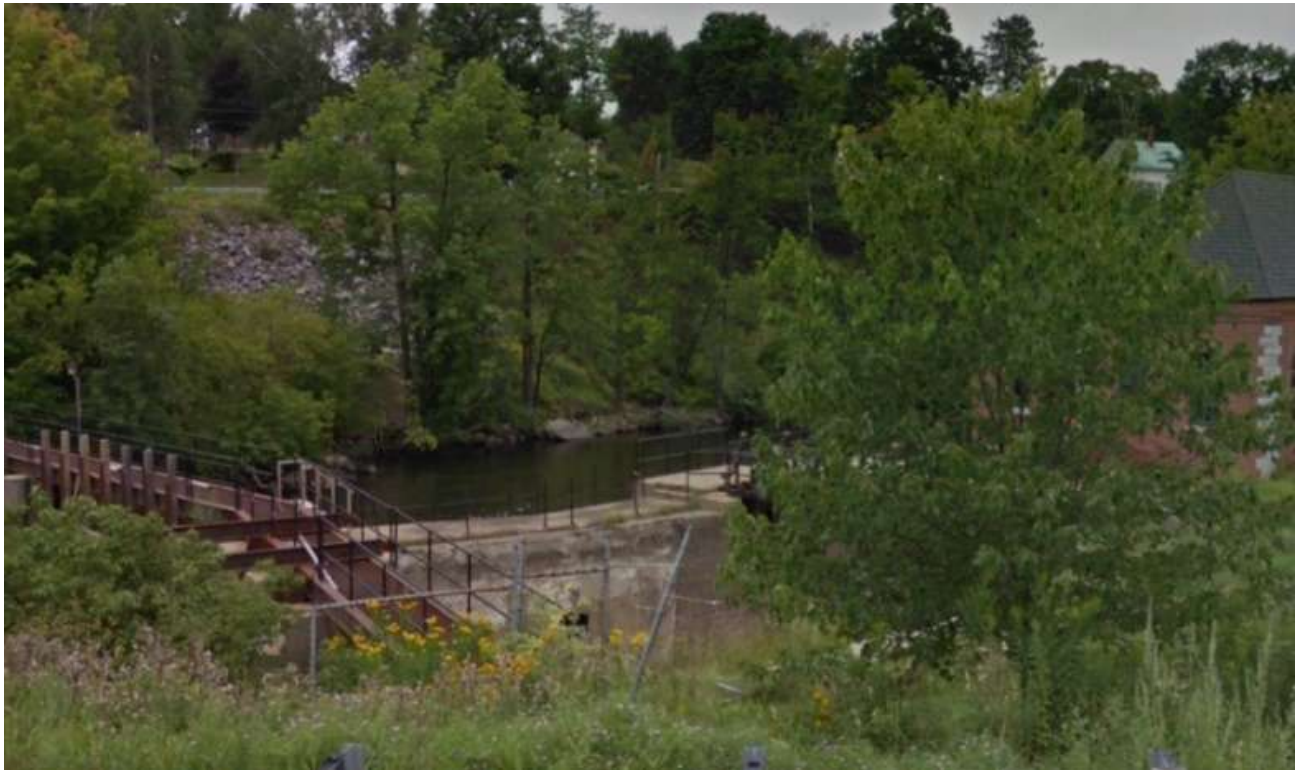
Based on historical imagery available through Google Street View and on observations during site visits after the May 2023 failure, the slopes were generally covered with brush, weeds, and scattered mature trees that provided vegetative cover and some degree of soil stabilization. Topographic surveys were completed after the May 2023 failure and before and after the December 2023 failure. Based on these surveys, the December 2023 failed portion was inclined at approximately 1.2 horizontal to 1 vertical (1.2H:1V) along the upper portion of the slope and approximately 2 horizontal to 1 vertical (2H:1V) along the lower portion closer to the stream prior to failure. Based on the similar terrain and geomorphic characteristics observed in adjacent areas, it is presumed that the May 2023 failed portion of the slope had a comparable inclination prior to the 2023 failure.

*Image 1-2: View of site prior to slope failure (Google Maps©)*

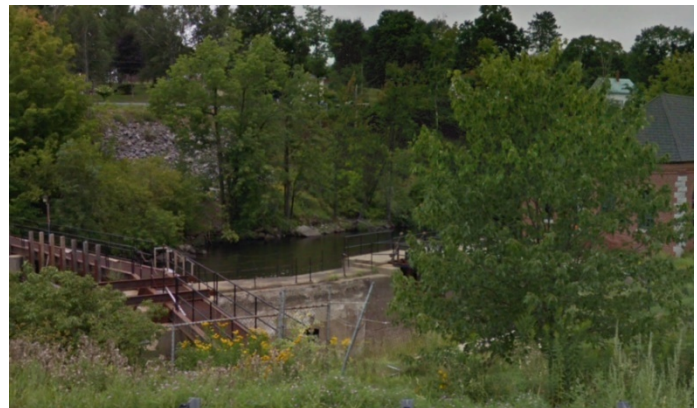
Based on historical street view photos from Google Maps®, the section of slope that failed on May 1, 2023 was covered with brush, weeds, and scattered trees prior to failure (see photo to the right). Based on a topographic survey plan completed for this project, the slope adjacent to the north side of the failed slope section is inclined at approximately 1.2H:1V at its upper portion and approximately 2H:1V at its lower portion. We assume that the failed section of slope was similarly inclined prior to failure. The slope in the area of the May 1, 2023 failure is approximately 40 feet tall.

*View of site prior to slope failure (Google Maps®)*

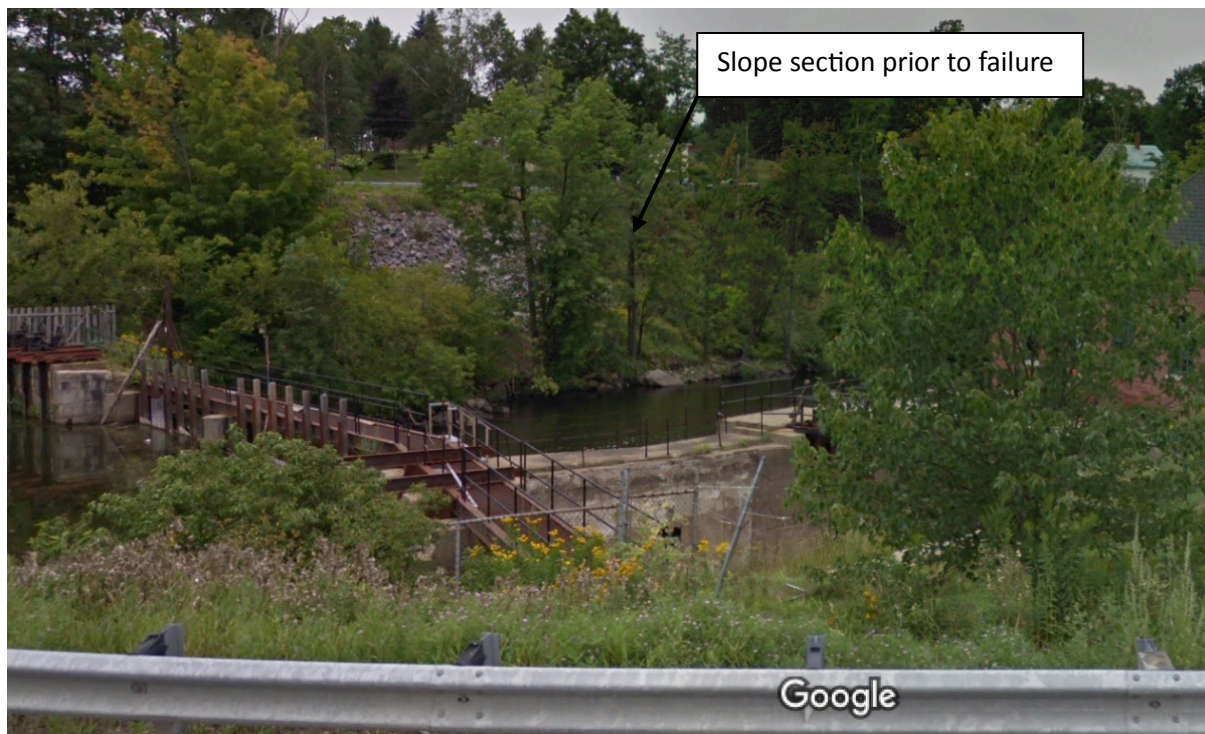
Photo 1 – Slope conditions prior to failure from Google Maps®

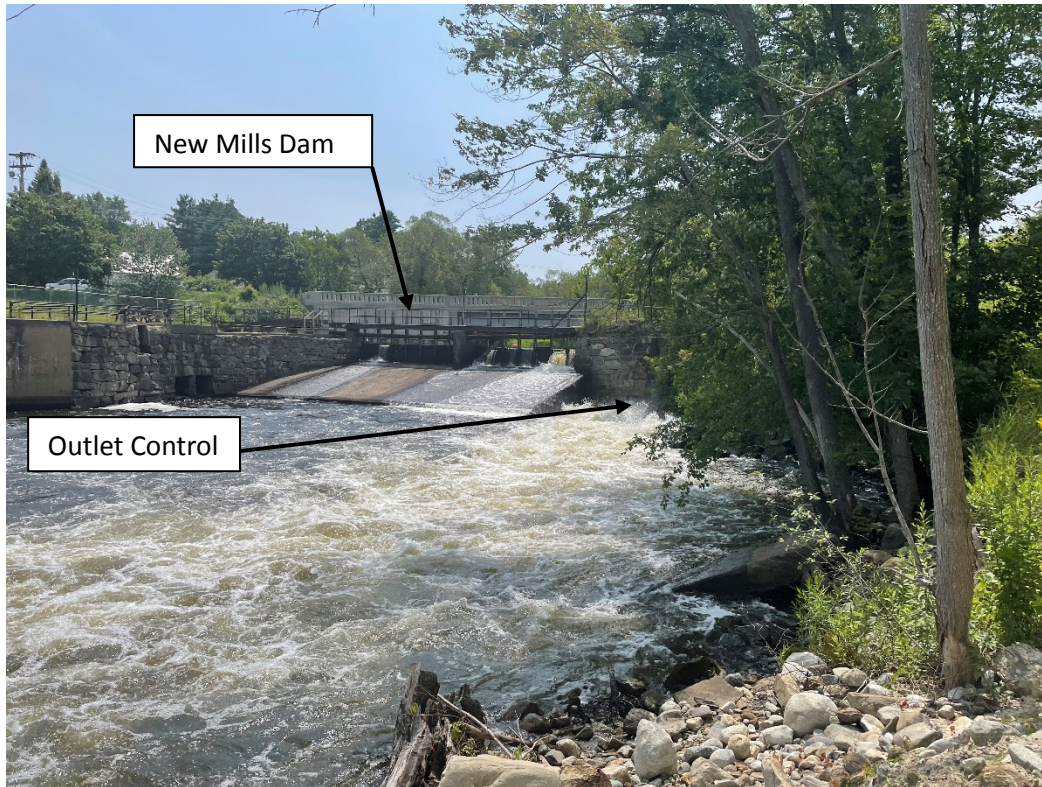
Photo 5 – Cobbosseecontee Stream and flow from New Mills Dam on August 3, 2023

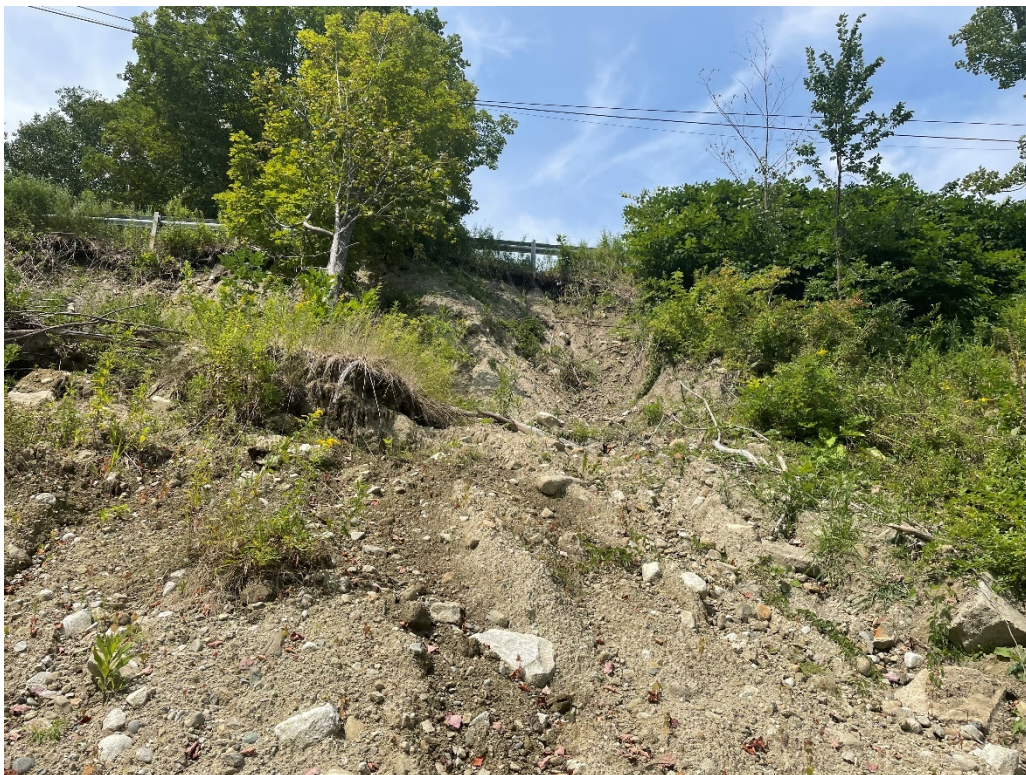
Photo 6 – Sloughed embankment soils on August 3, 2023

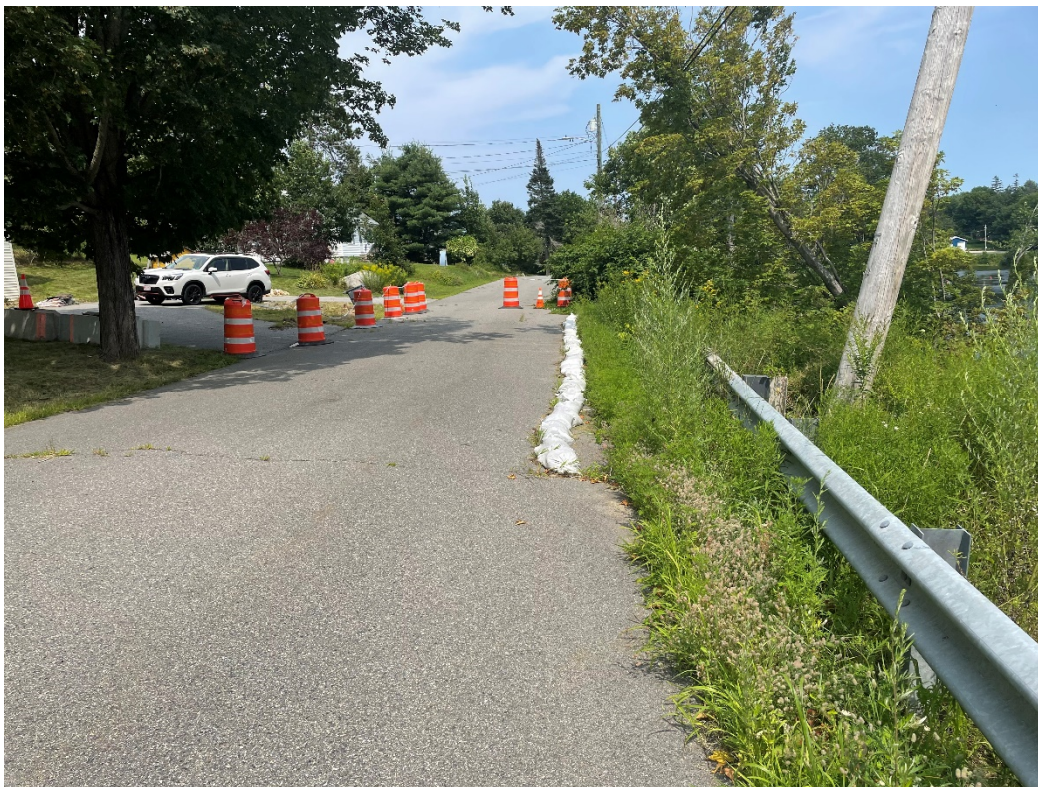
The failures also caused undermining and loss of supporting soil along the eastern edge of the paved surface of Harrison Avenue. Soil loss was observed around the posts supporting the existing metal guardrail, further reducing the stability of the roadside safety barrier. In addition, the failures reduced the lateral support for a nearby timber utility pole located along the east side of the roadway. As a result of the soil loss, the pole has rotated toward the slope and is considered structurally compromised.

Photo 7 – Rotated utility pole and tree on overhead utility lines of August 3, 2023

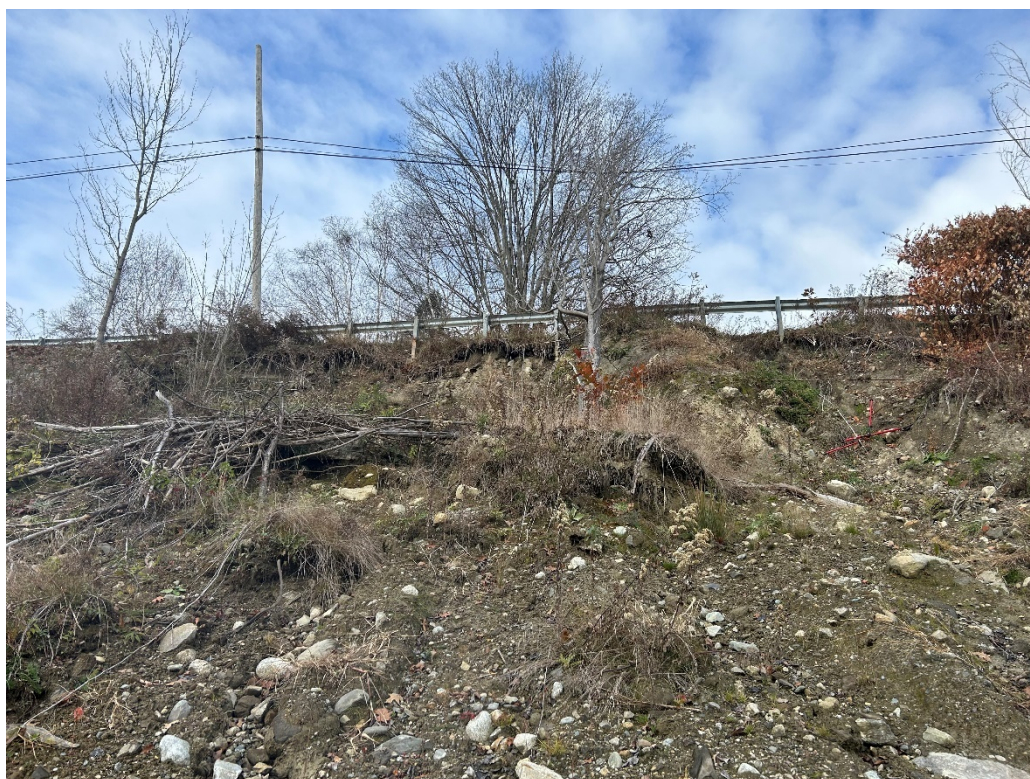
Photo 8 – Sloughed embankment soils on November 14, 2023

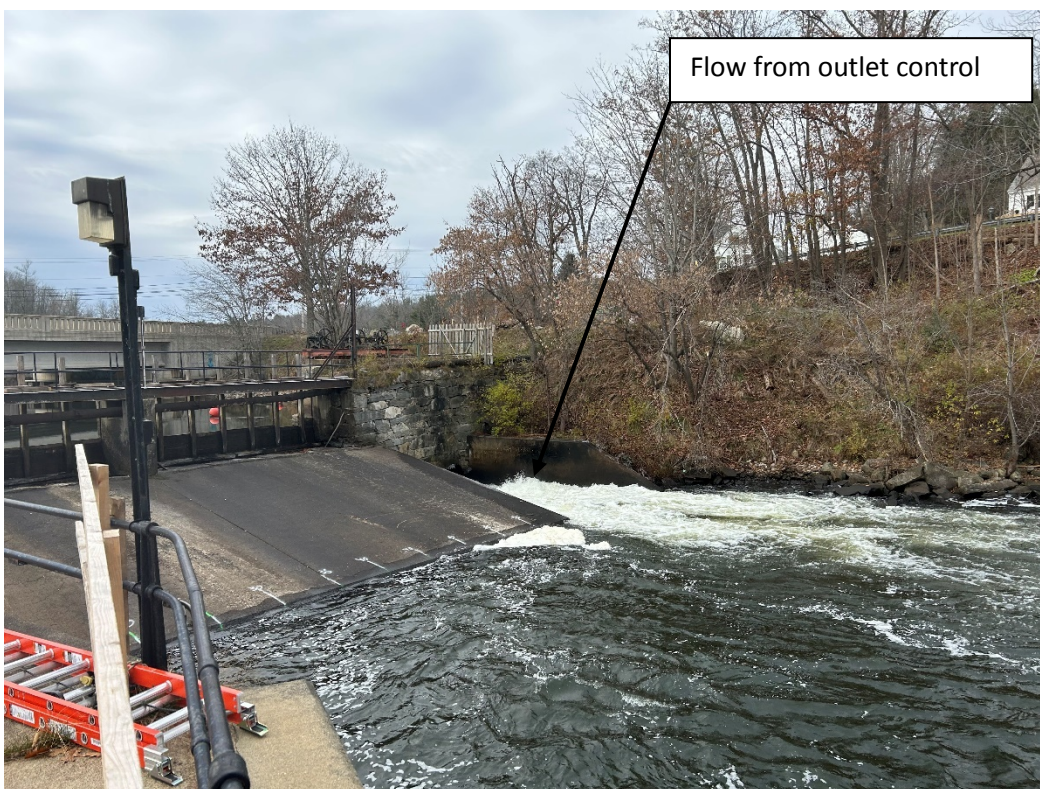
Photo 10 – New Mills Dam and flow form outlet control on November 14, 2023

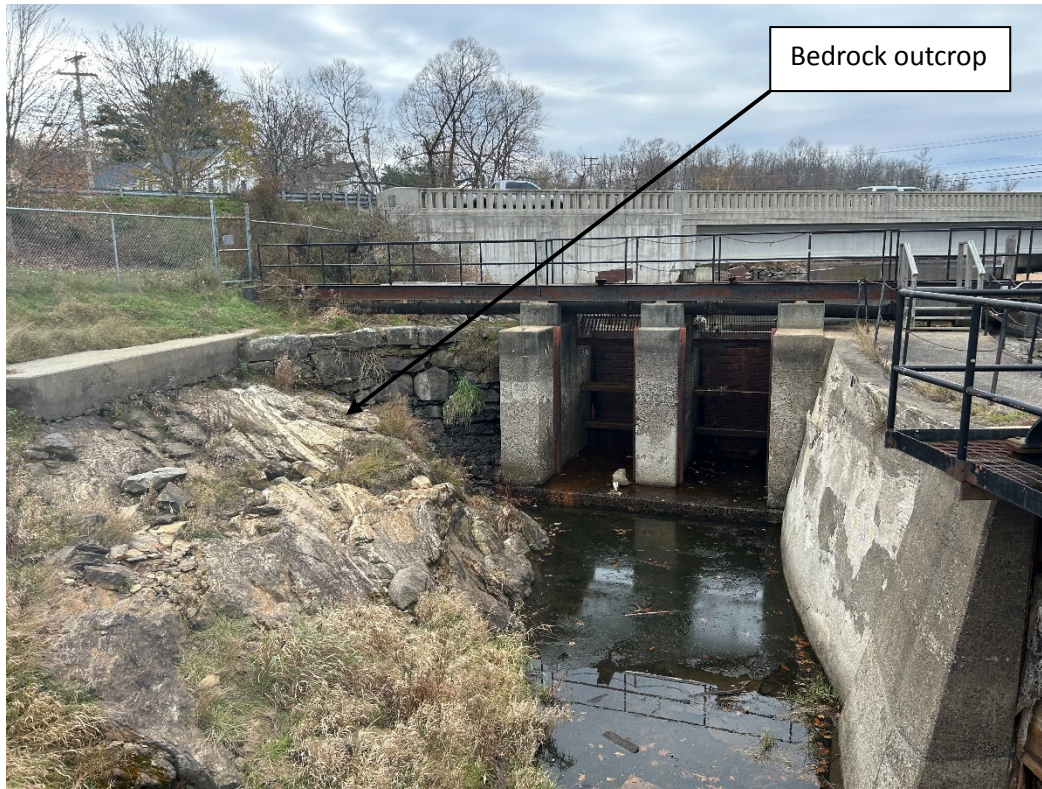
Photo 11 – Bedrock outcrops on east bank of the Cobbosseecontee Stream on November 14, 2023

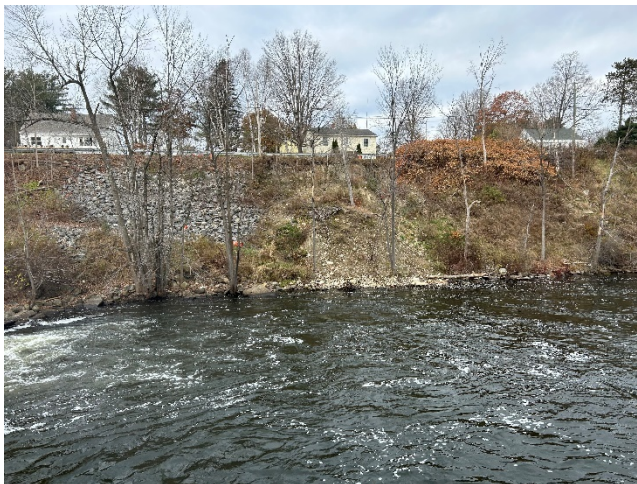
Based on observations during site visits for the May 1, 2023 failure project, the slope prior to the December 18, 2023 failure was covered with brush, weeds, and scattered trees. The photo to the right shows the slope in November 2023, with the May 1, 2023 failure immediately to the left (south) of the pre-failure slope section. According to a topographic survey completed in August and November 2023, the December 18, 2023 failed slope section was inclined at approximately 1.2H:1V at its upper portion and approximately 2H:1V at its lower portion prior to failure. Ground surface elevations prior to failure ranged from approximately El. 166 feet at the top of the slope to approximately El. 124 feet at the bottom of the slope.

*View of slope prior to failure in November 2023*

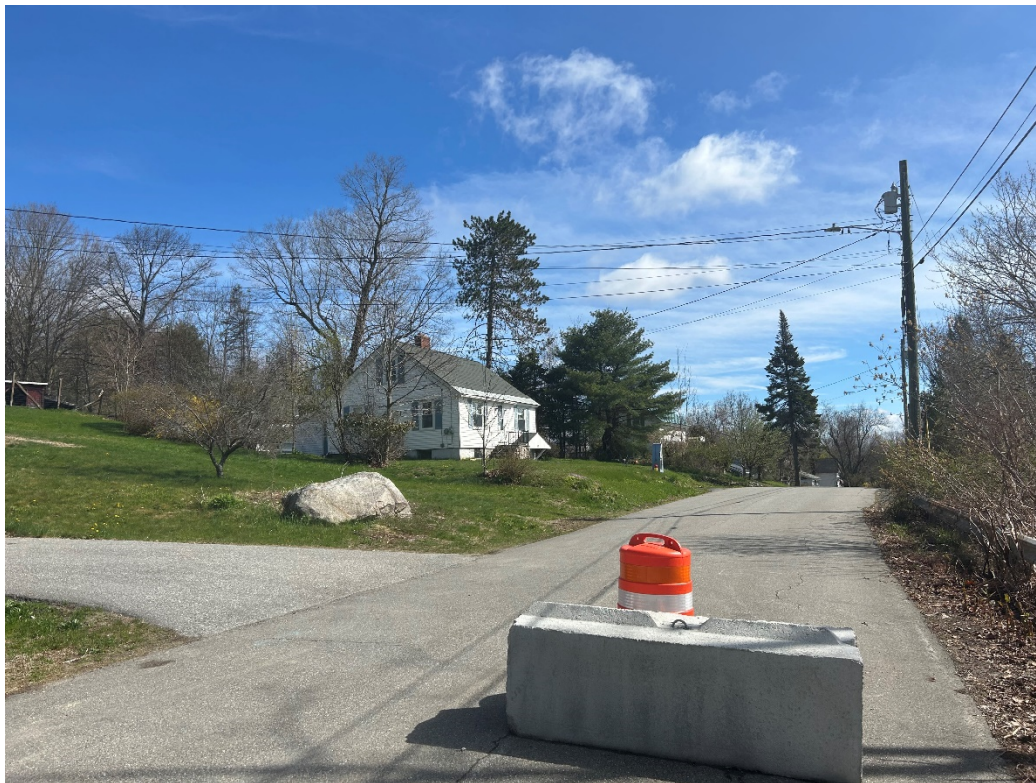
Photo 6 – View of Harrison Ave looking north on May 3, 2024
